LIMITED CONDITION ASSESSMENT REPORT

OKLAHOMA COUNTY DETENTION CENTER 201 N. SHARTEL AVENUE OKLAHOMA CITY, OKLAHOMA

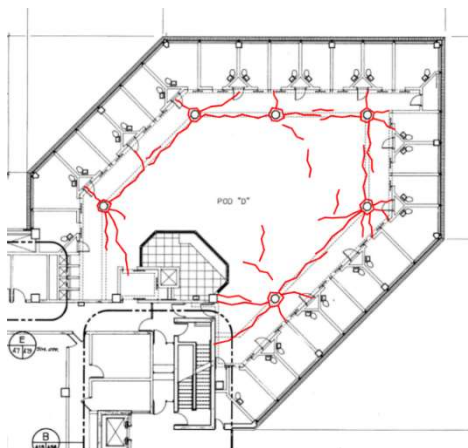
Figure 5 – Graphical image of cracking observed in the floor for a typical pod

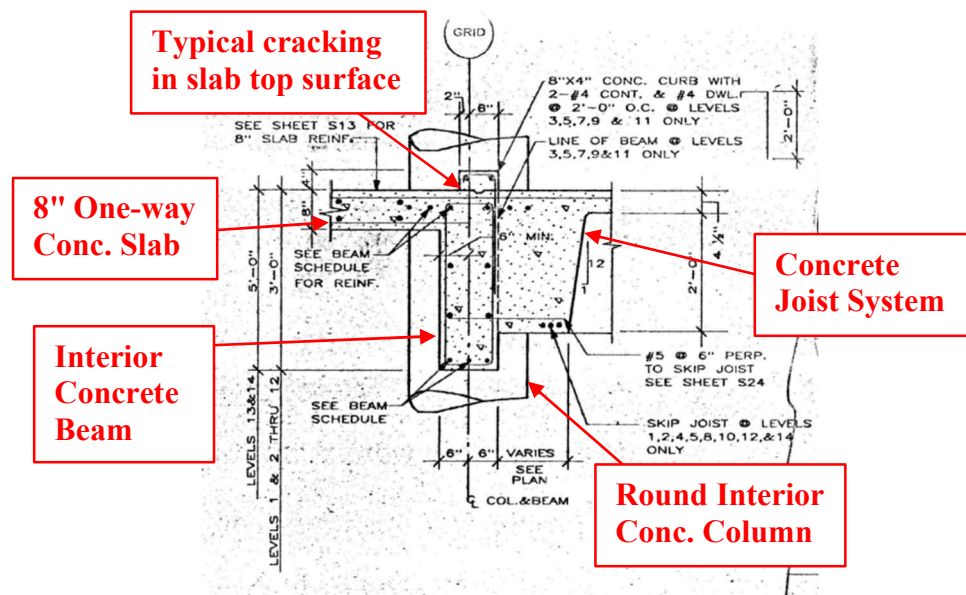
Figure 6 - Typical section at large interior floor beam

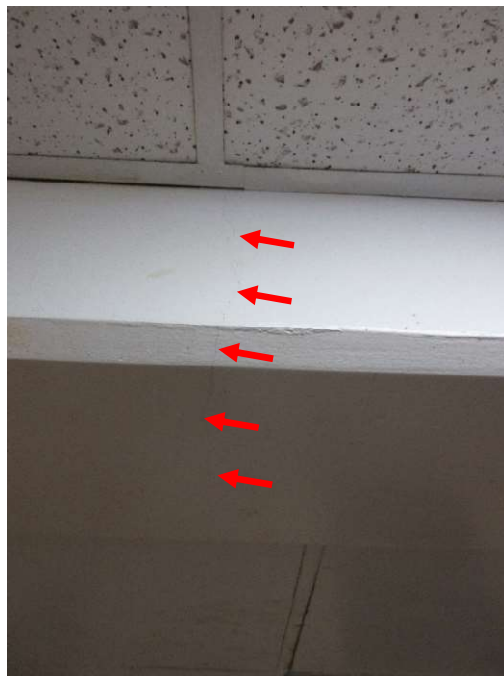
Photo 6 – Hairline crack in rectangular beam at Level 14

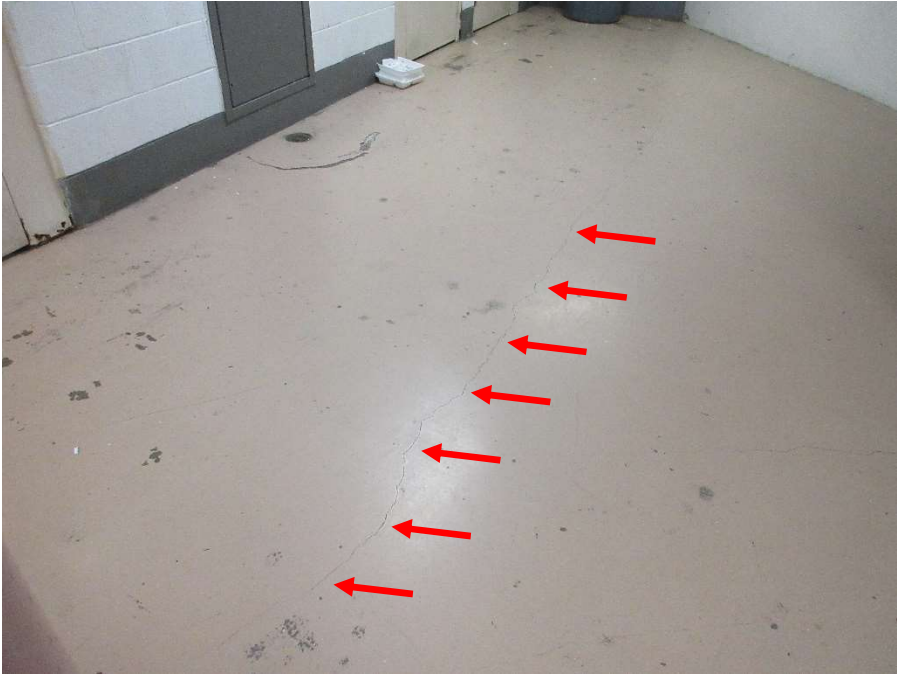
Photo 7 - Cracking in slab top surface at Level 13

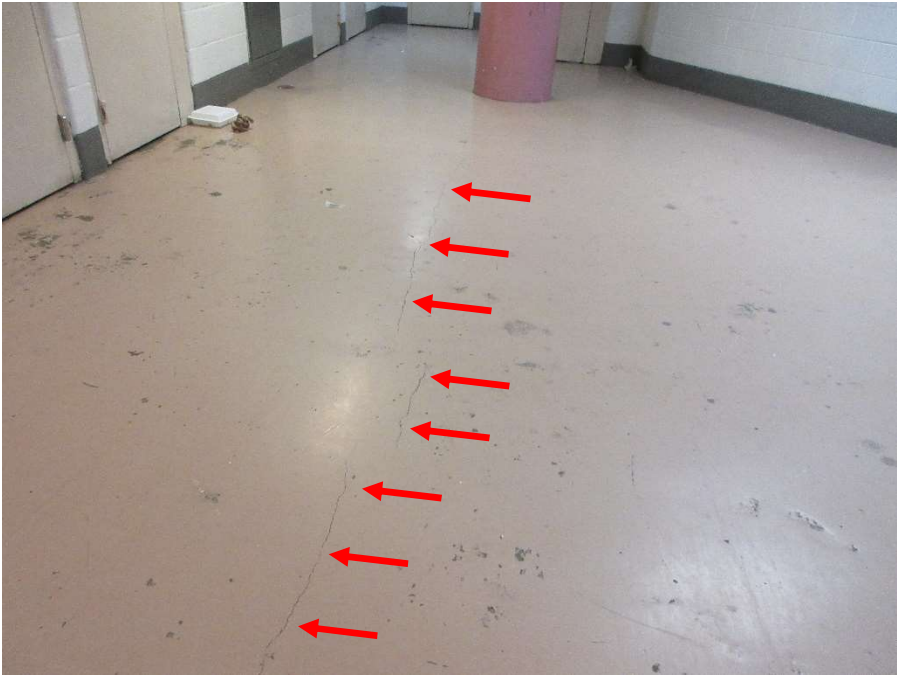
Photo 8 - Cracking in slab top surface at Level 13

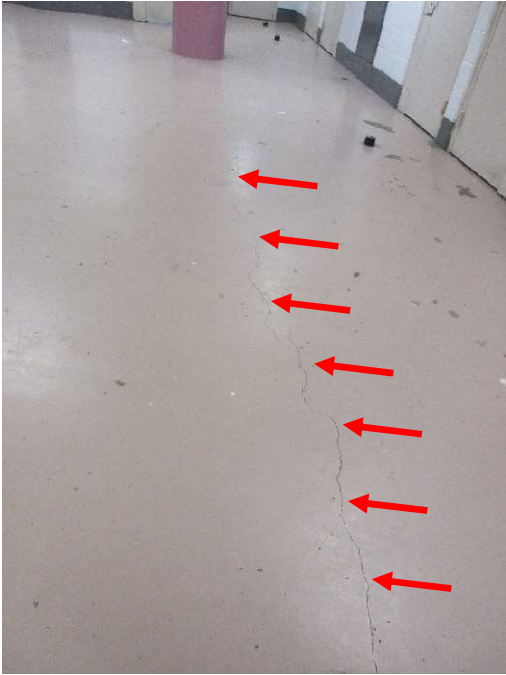
Photo 9 - Cracking in slab top surface at Level 13

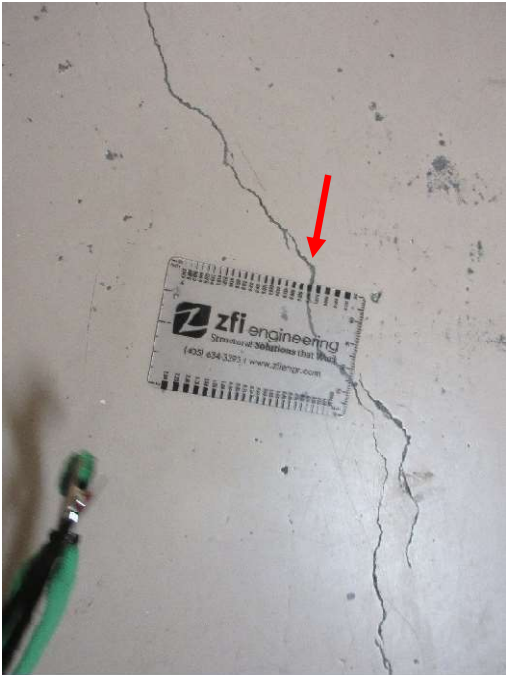
Photo 10 - Approximate width (0.060") of crack in slab top surface at Level 13

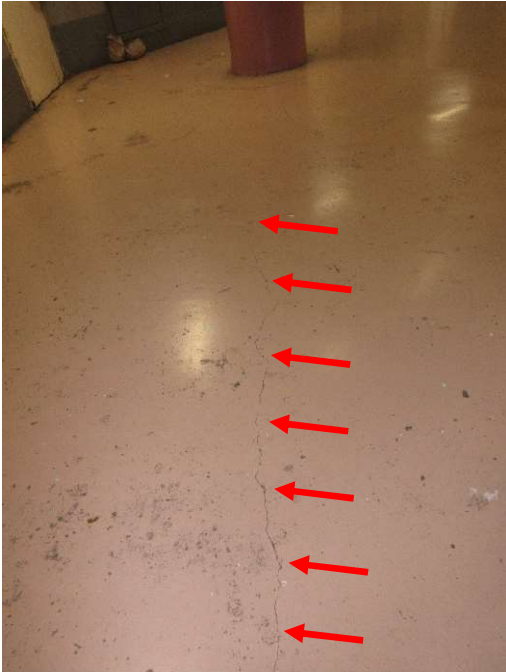
Photo 11 - Cracking in slab top surface at Level 10

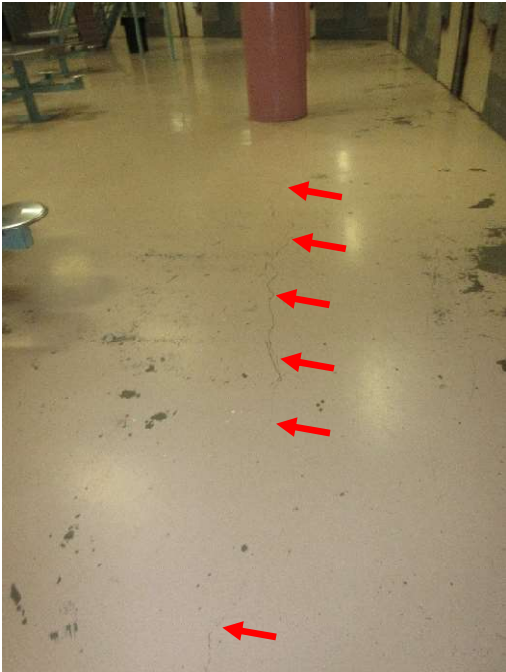
Photo 12 - Cracking in slab top surface at Level 10

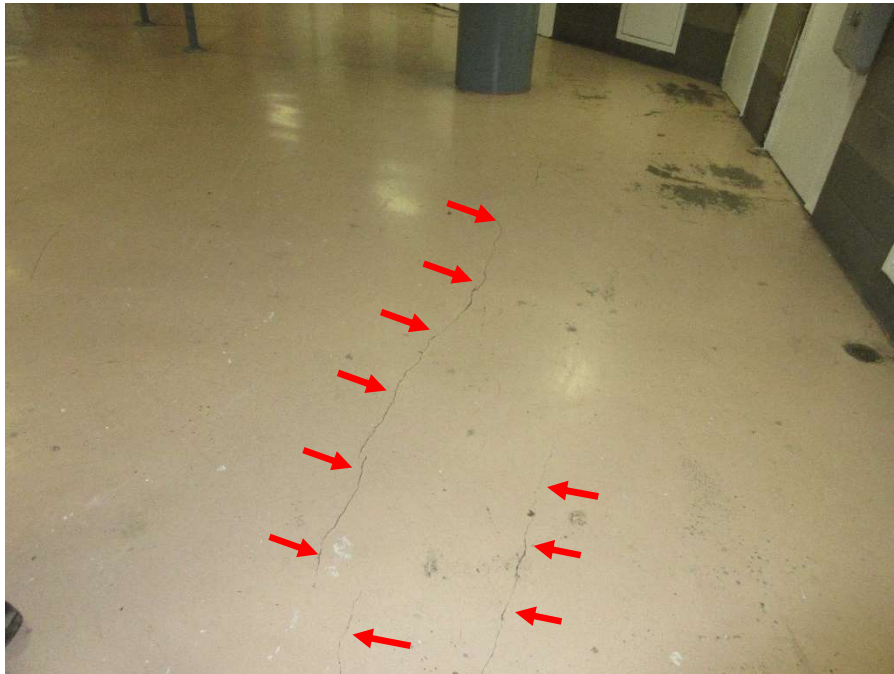
Photo 13 - Cracking in slab top surface at Level 8

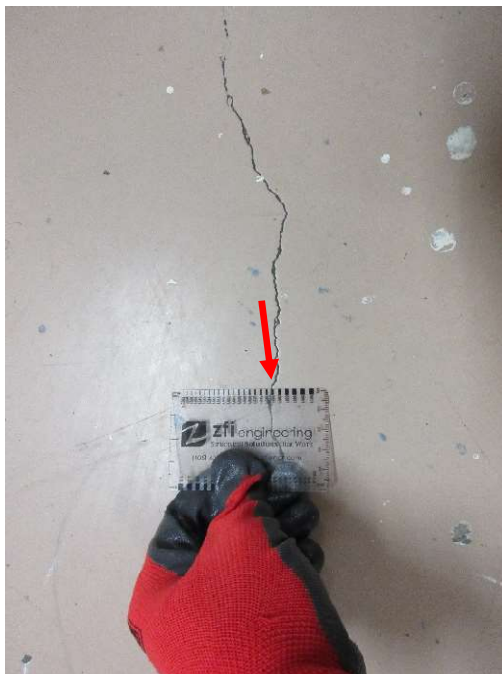
Photo 14 - Approximate width (0.050") of crack in slab top surface at Level 8

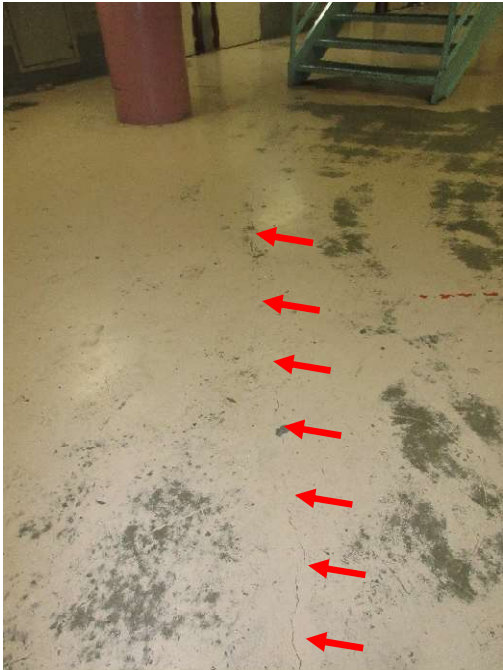
Photo 15 - Cracking in slab top surface at Level 4

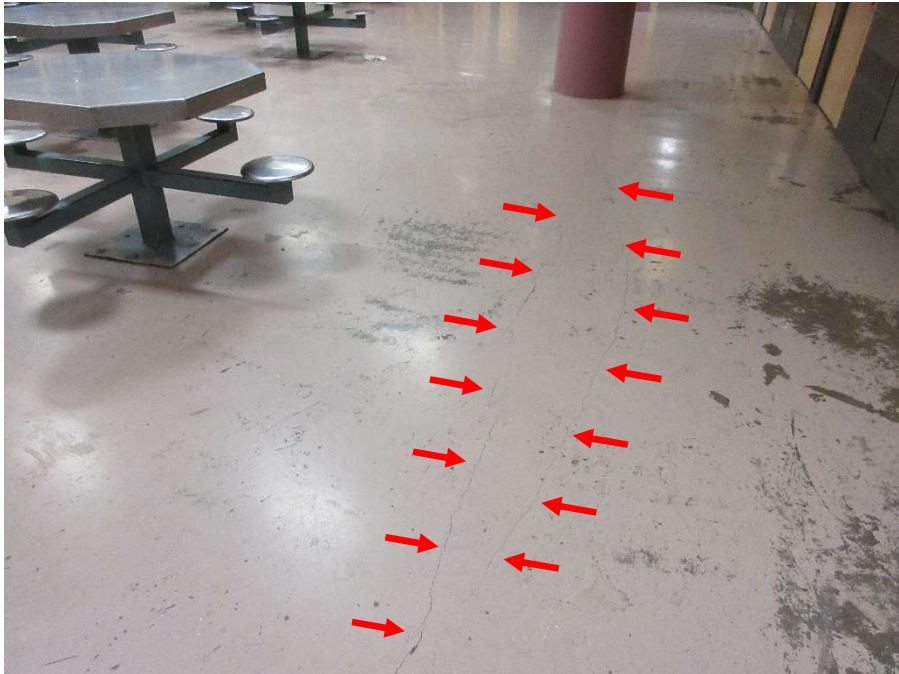
Photo 16 - Cracking in slab top surface at Level 2

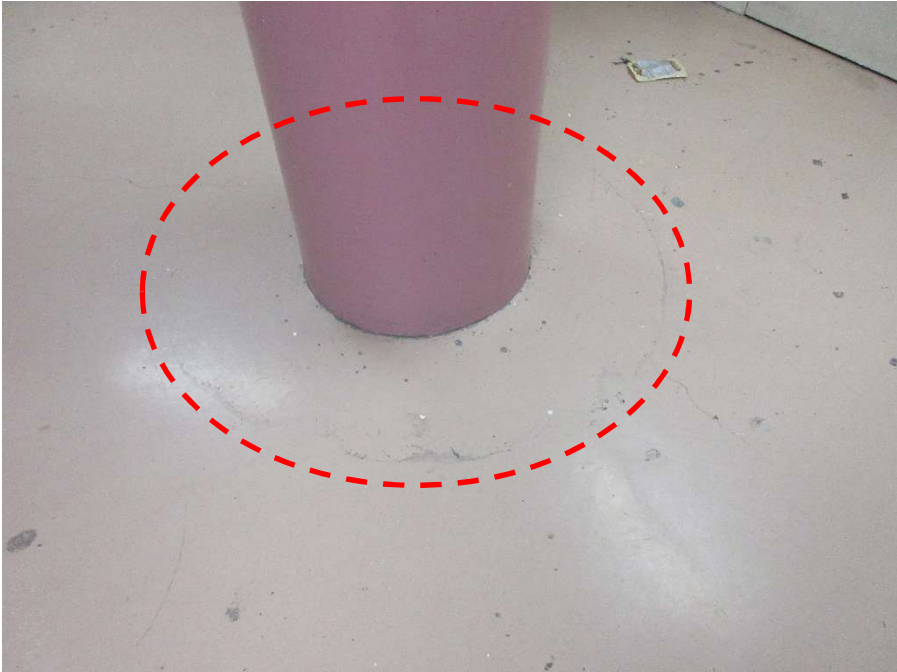
Photo 17 – Circular construction joint around column at Level 13

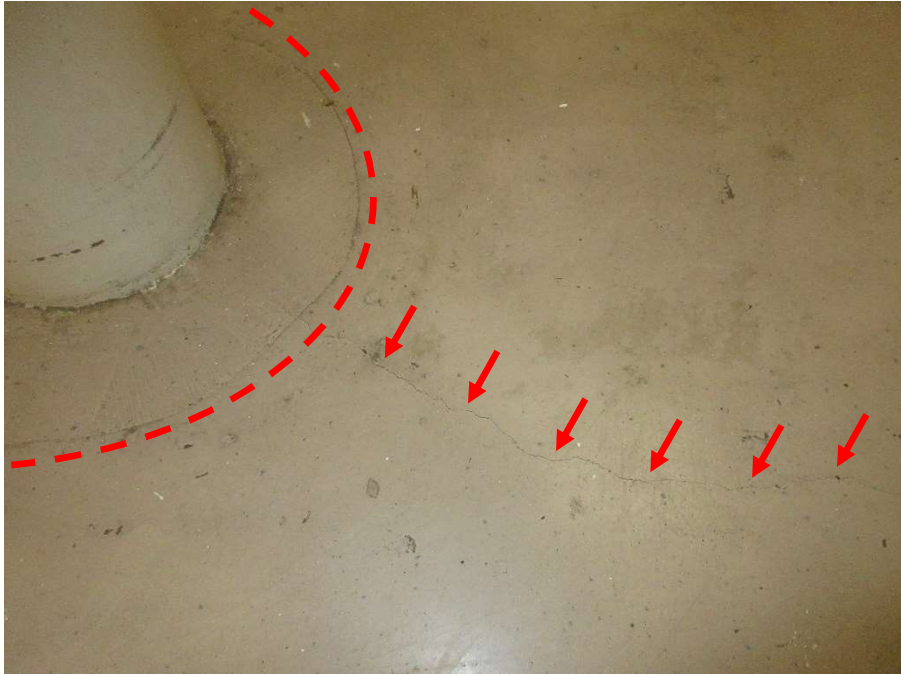
Photo 19 – Circular construction joint & cracks at Level 12

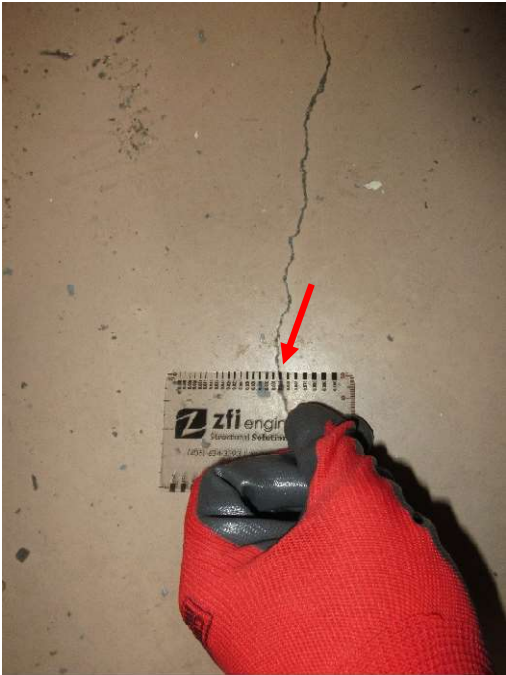
Photo 20 – Approximate width (0.040") of crack in slab top surface at Level 12

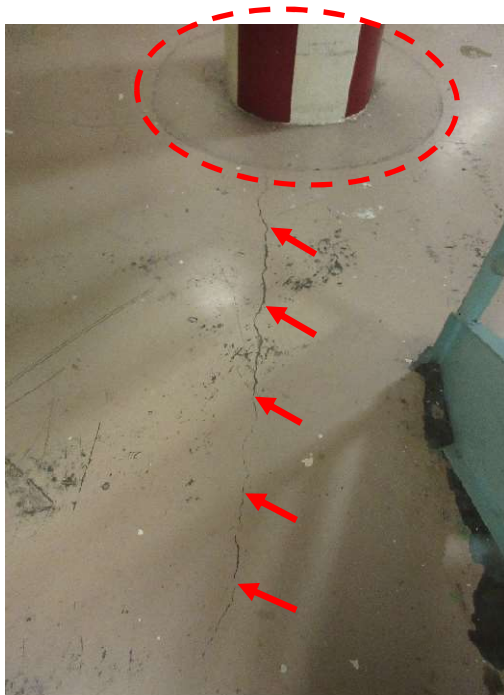
Photo 21 – Circular construction joint & cracks at Level 10

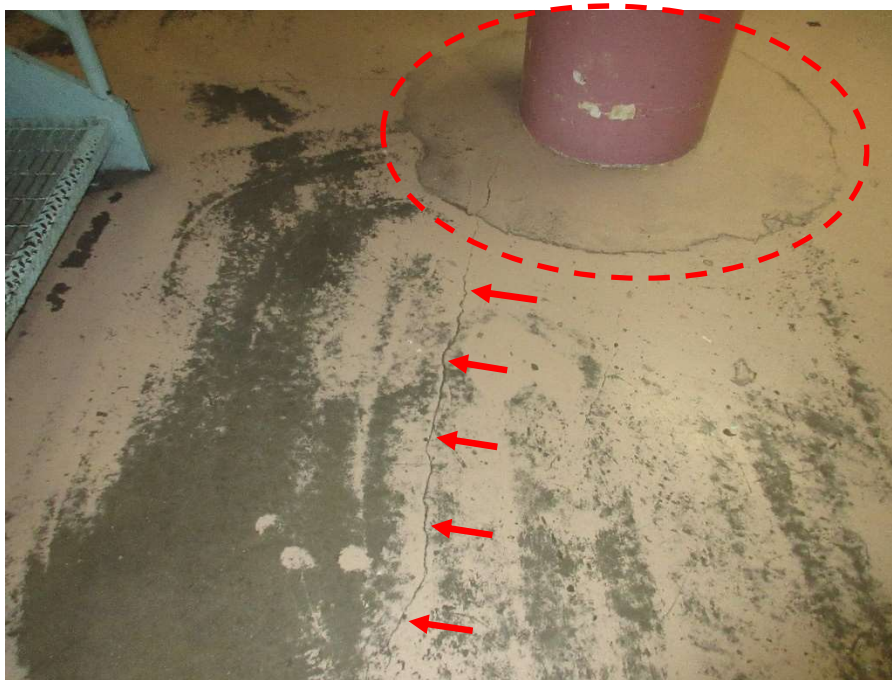
Photo 22 – Circular construction joint & cracks at Level 4

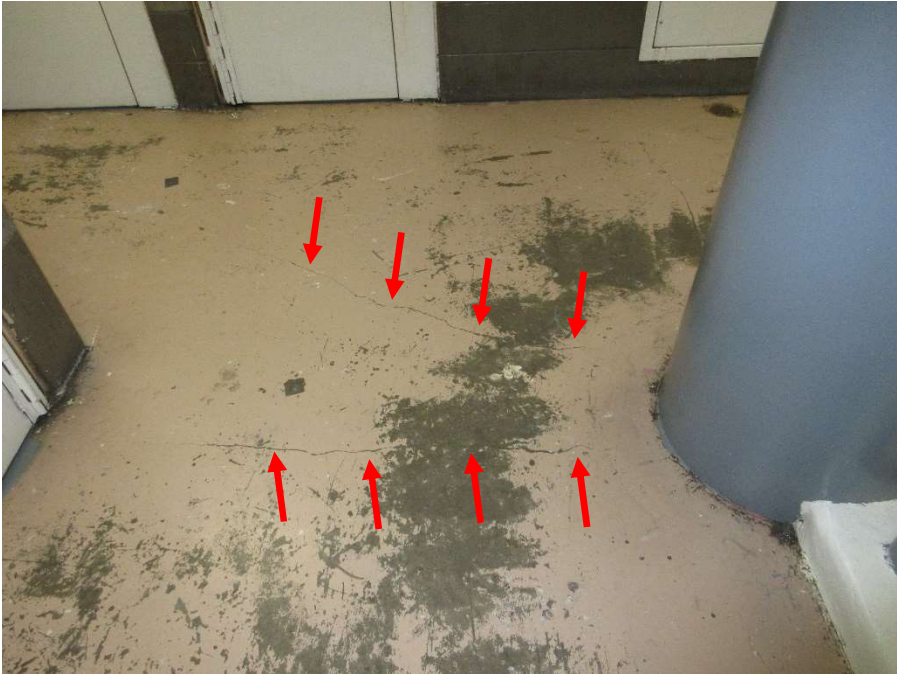
Photo 23 - Cracking in slab top surface at Level 9

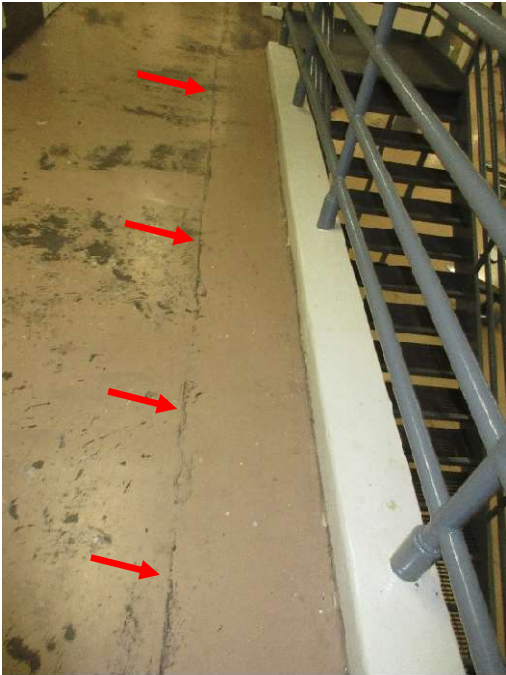
Photo 24 - Construction joint in slab top surface at Level 9

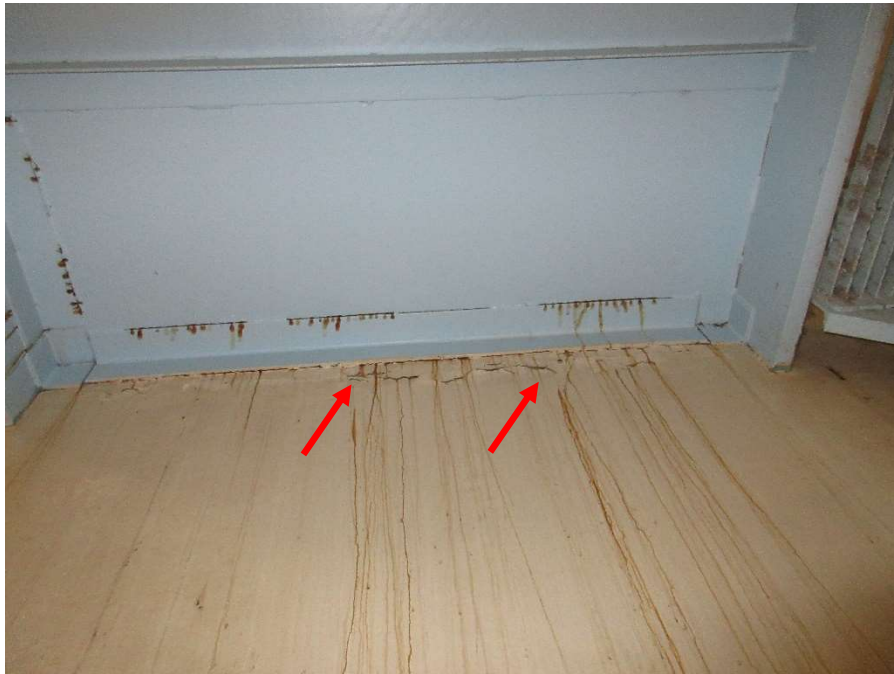
Photo 25 – Corrosion of edge framing at stair landing

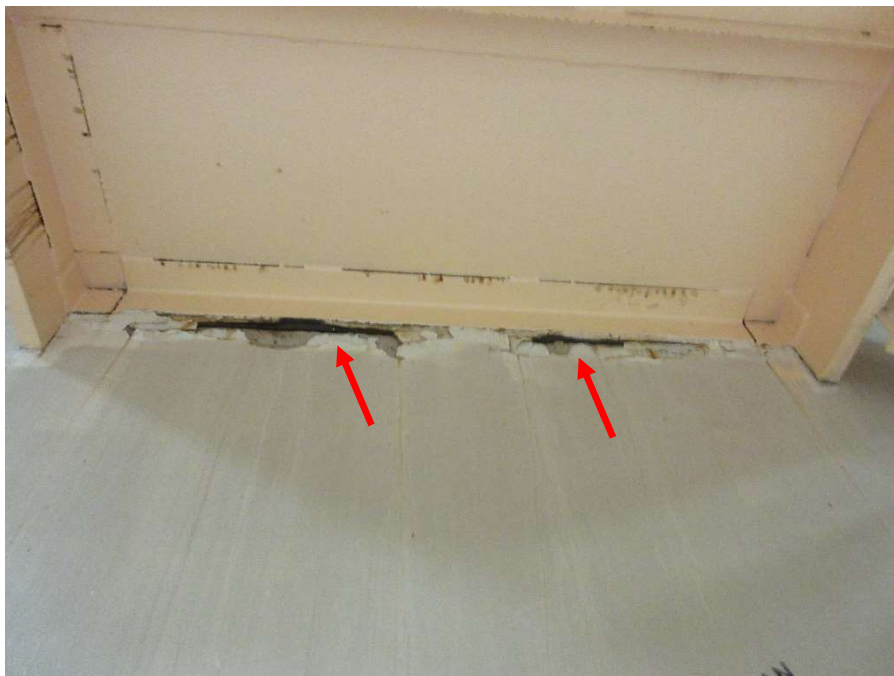
Photo 26 – Corrosion of edge framing at stair landing

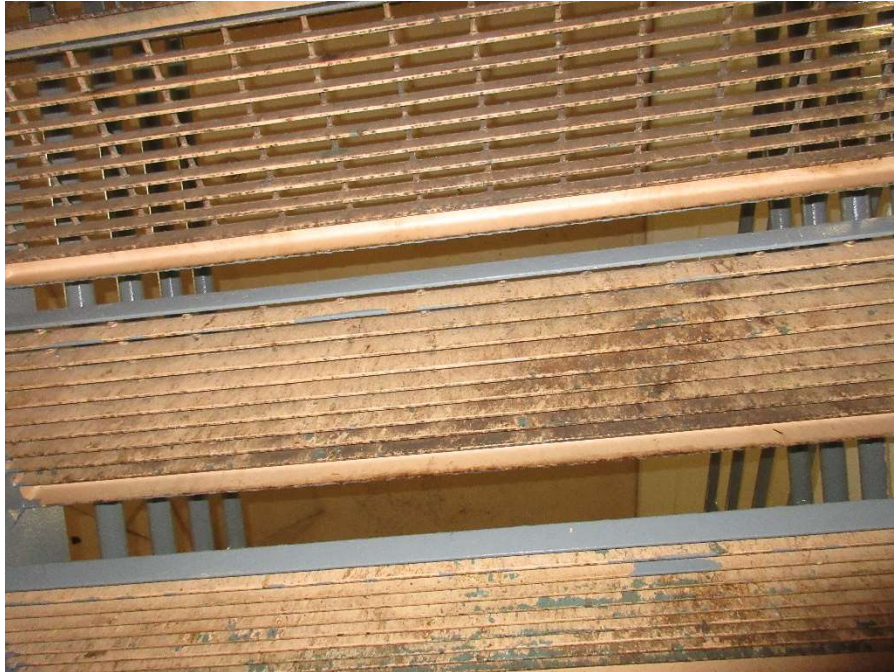
Photo 27 - Minor corrosion of steel treads at stair

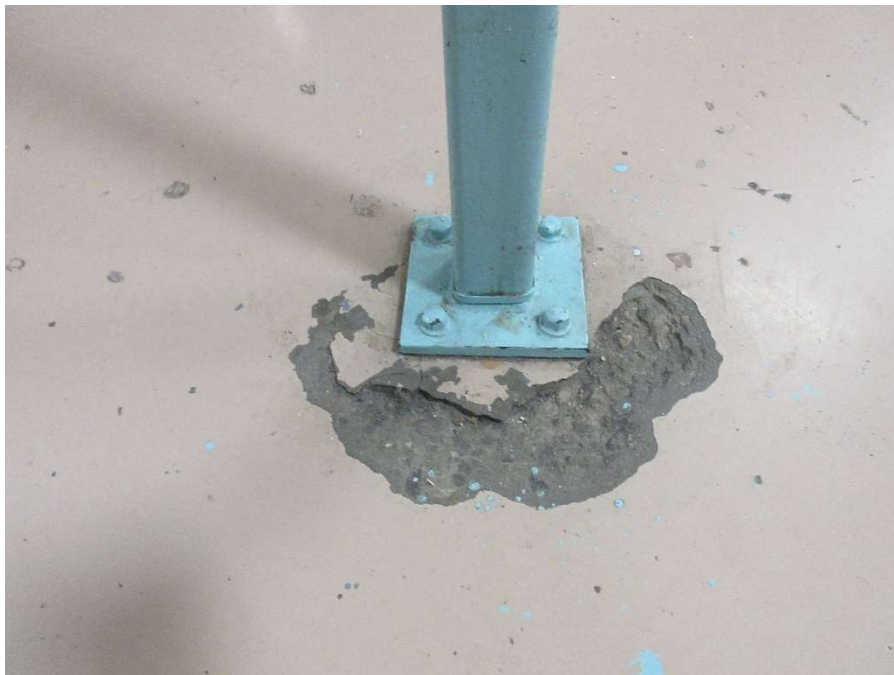
Photo 28 - Concrete damage at base of stair column

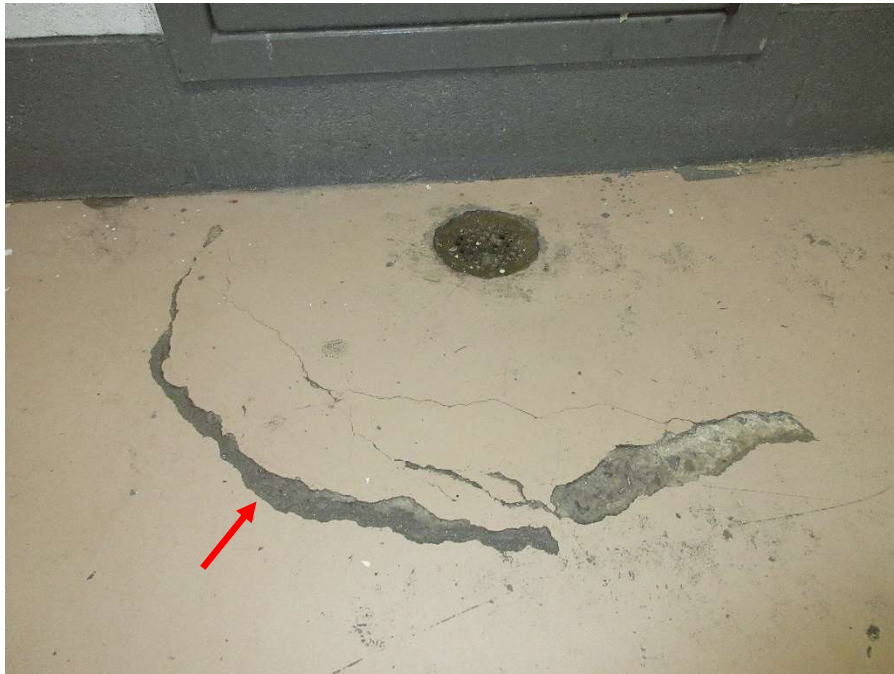
Photo 29 - Concrete damage near floor drain at Level 13

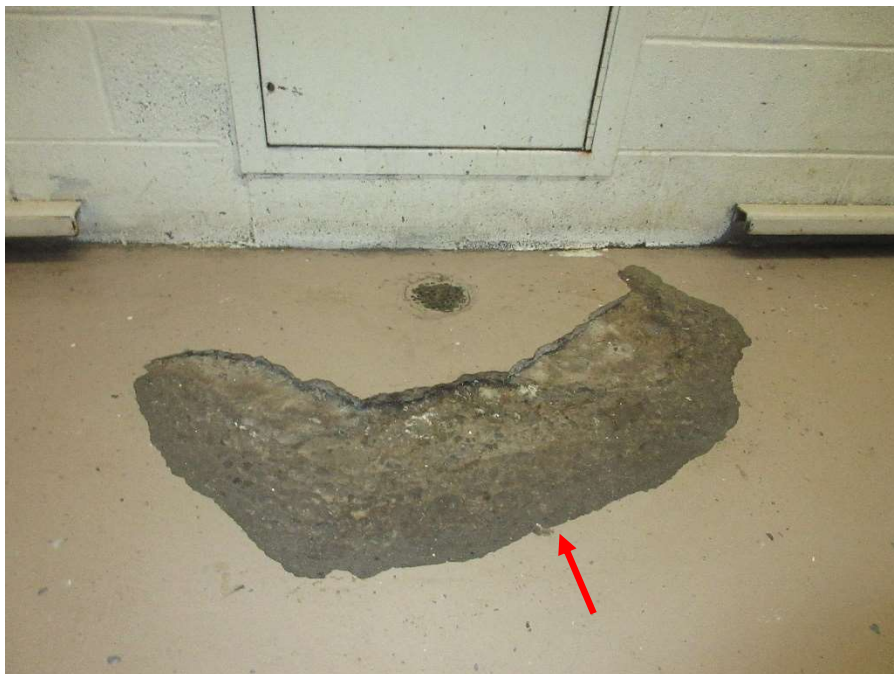
Photo 30 - Concrete damage near floor drain at Level 12

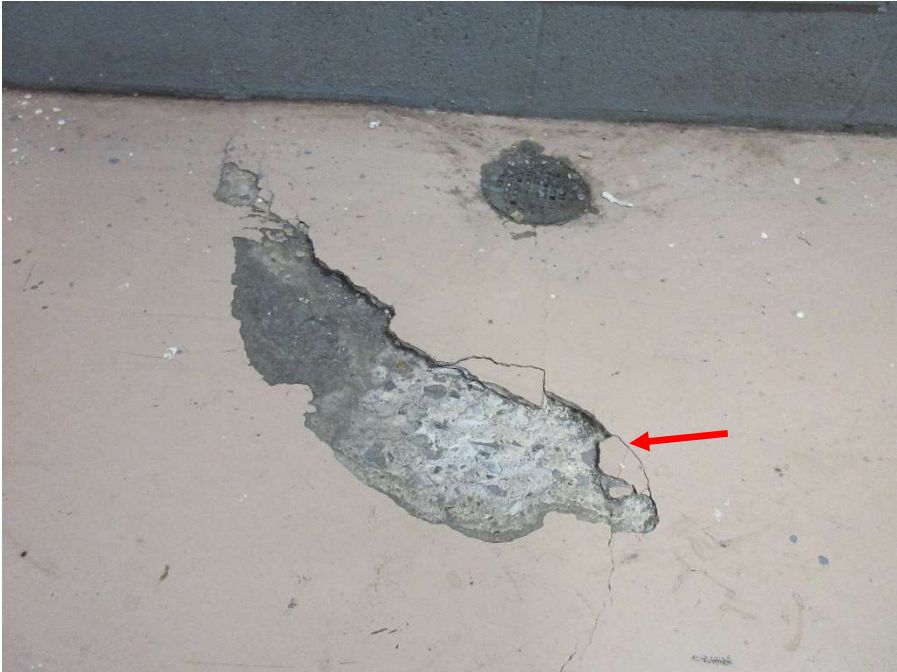
Photo 31 - Concrete damage near floor drain at Level 10

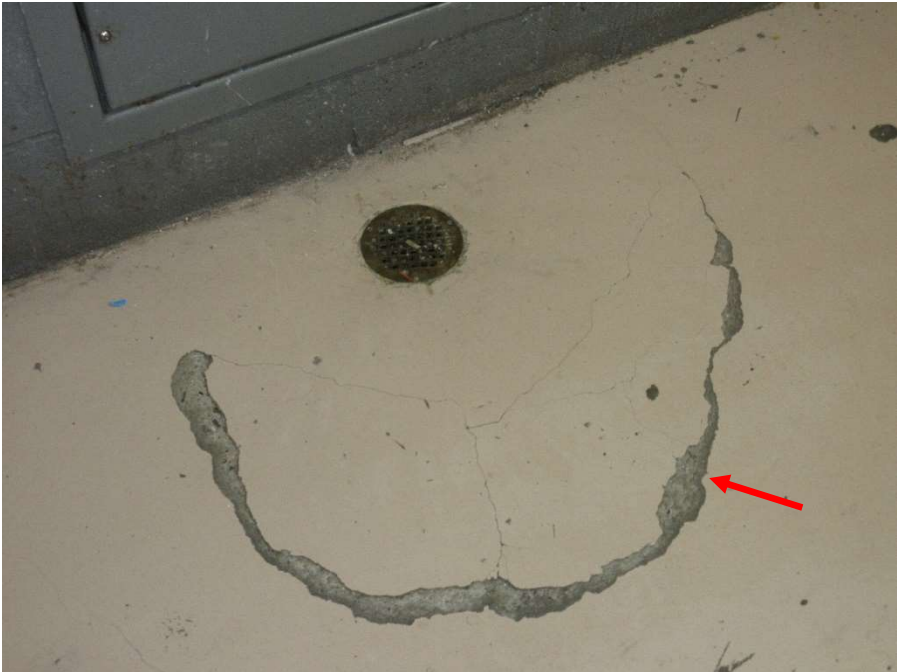
Photo 32 - Concrete damage near floor drain at Level 2

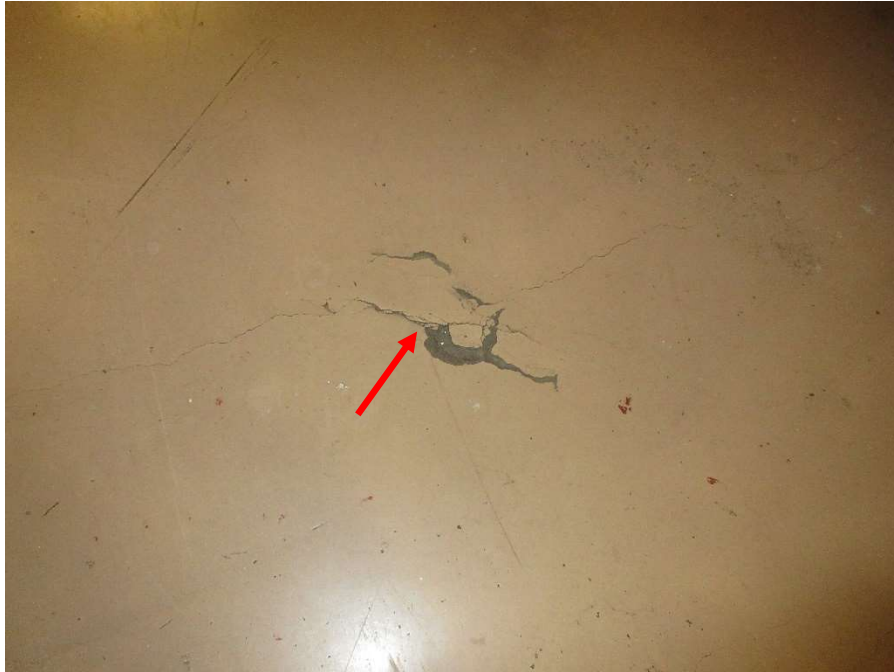
Photo 33 – Concrete delamination along crack at Level 10

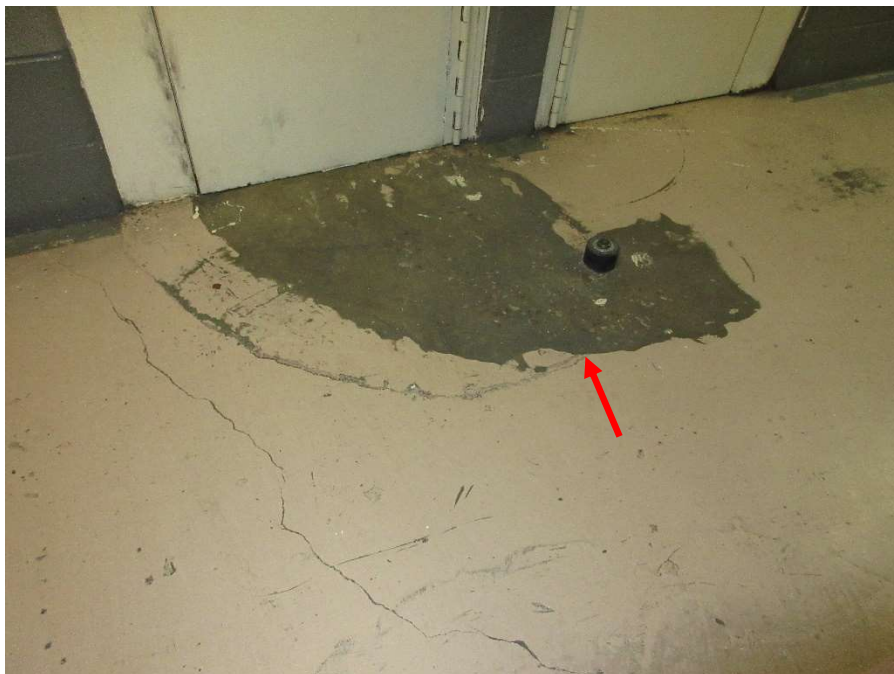
Photo 34 – Significant abrasion of concrete surface at Level 4

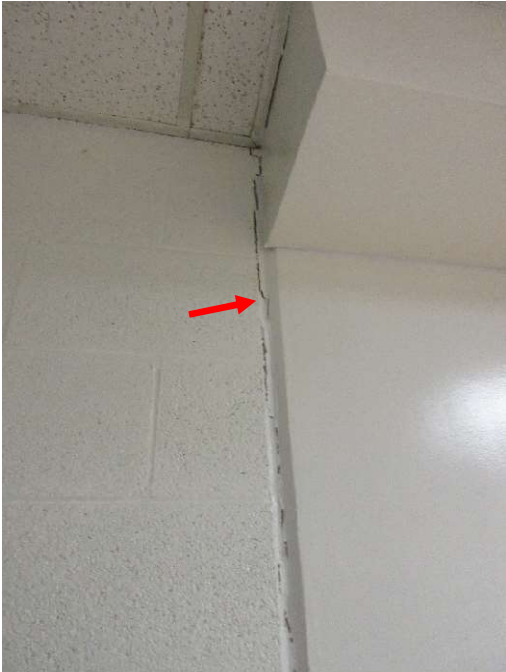
Photo 35 – Cracking in sealant of vertical joint at interior wall @ Level 13

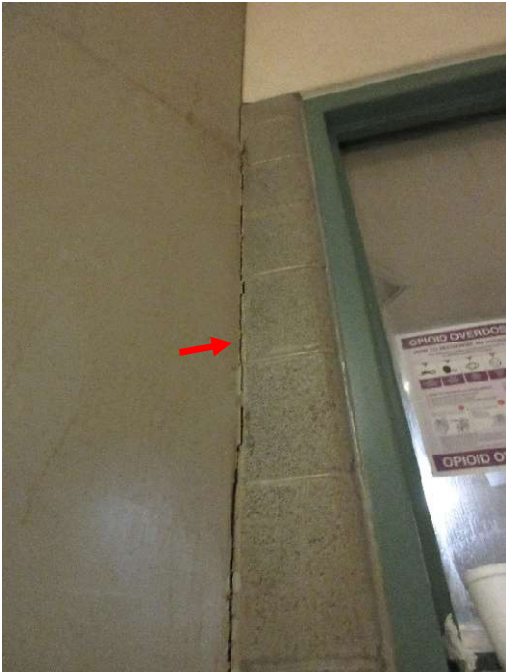
Photo 36 – Cracking in finishes at interior wall @ Level 4

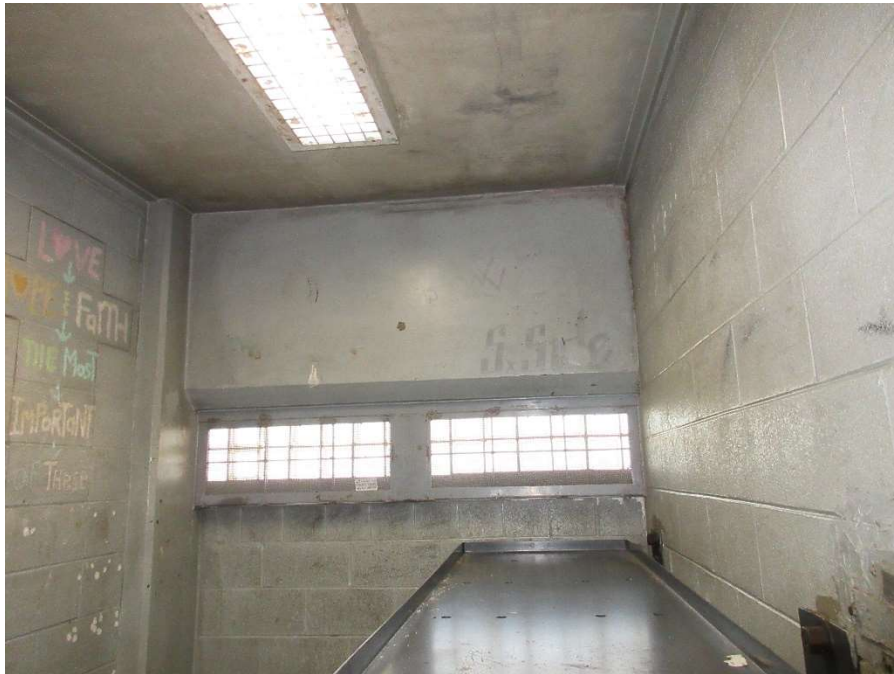
Photo 37 – General view of typical cell at Level 6

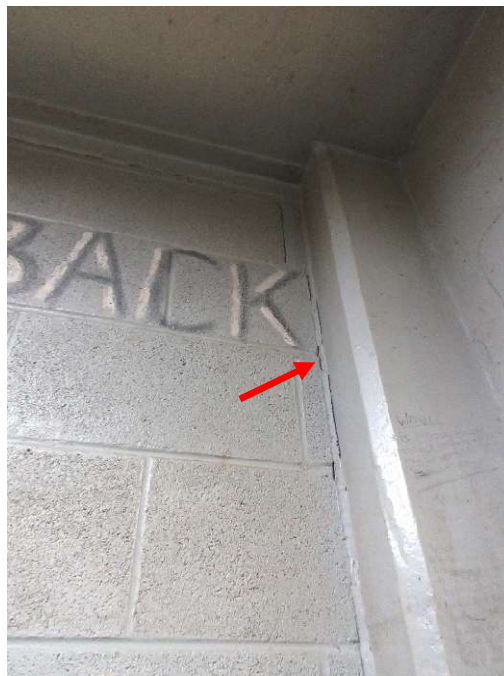
Photo 38 – Cracking in sealant of vertical joint at cell wall

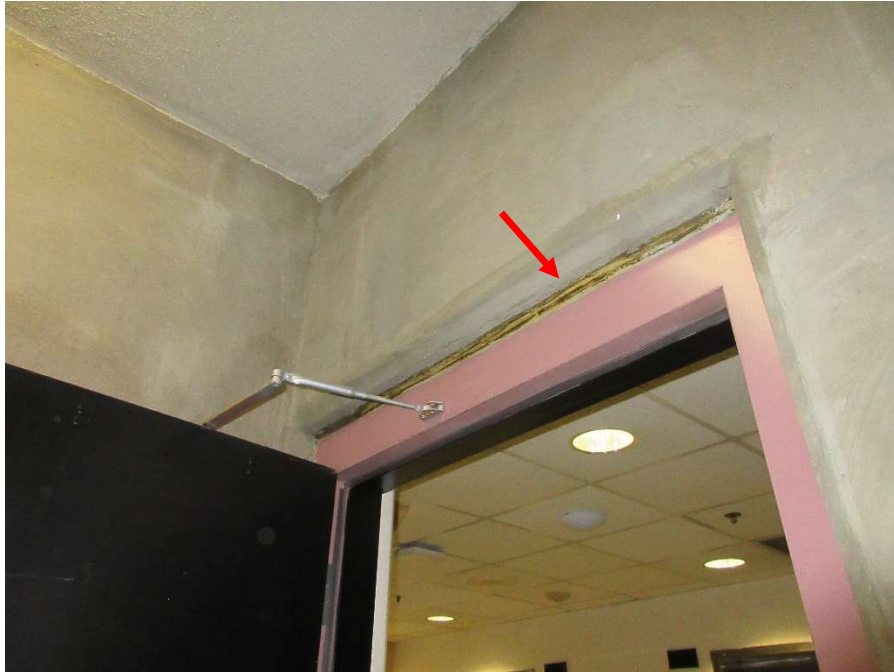
Photo 39 – Distress at door frame of stairwell
