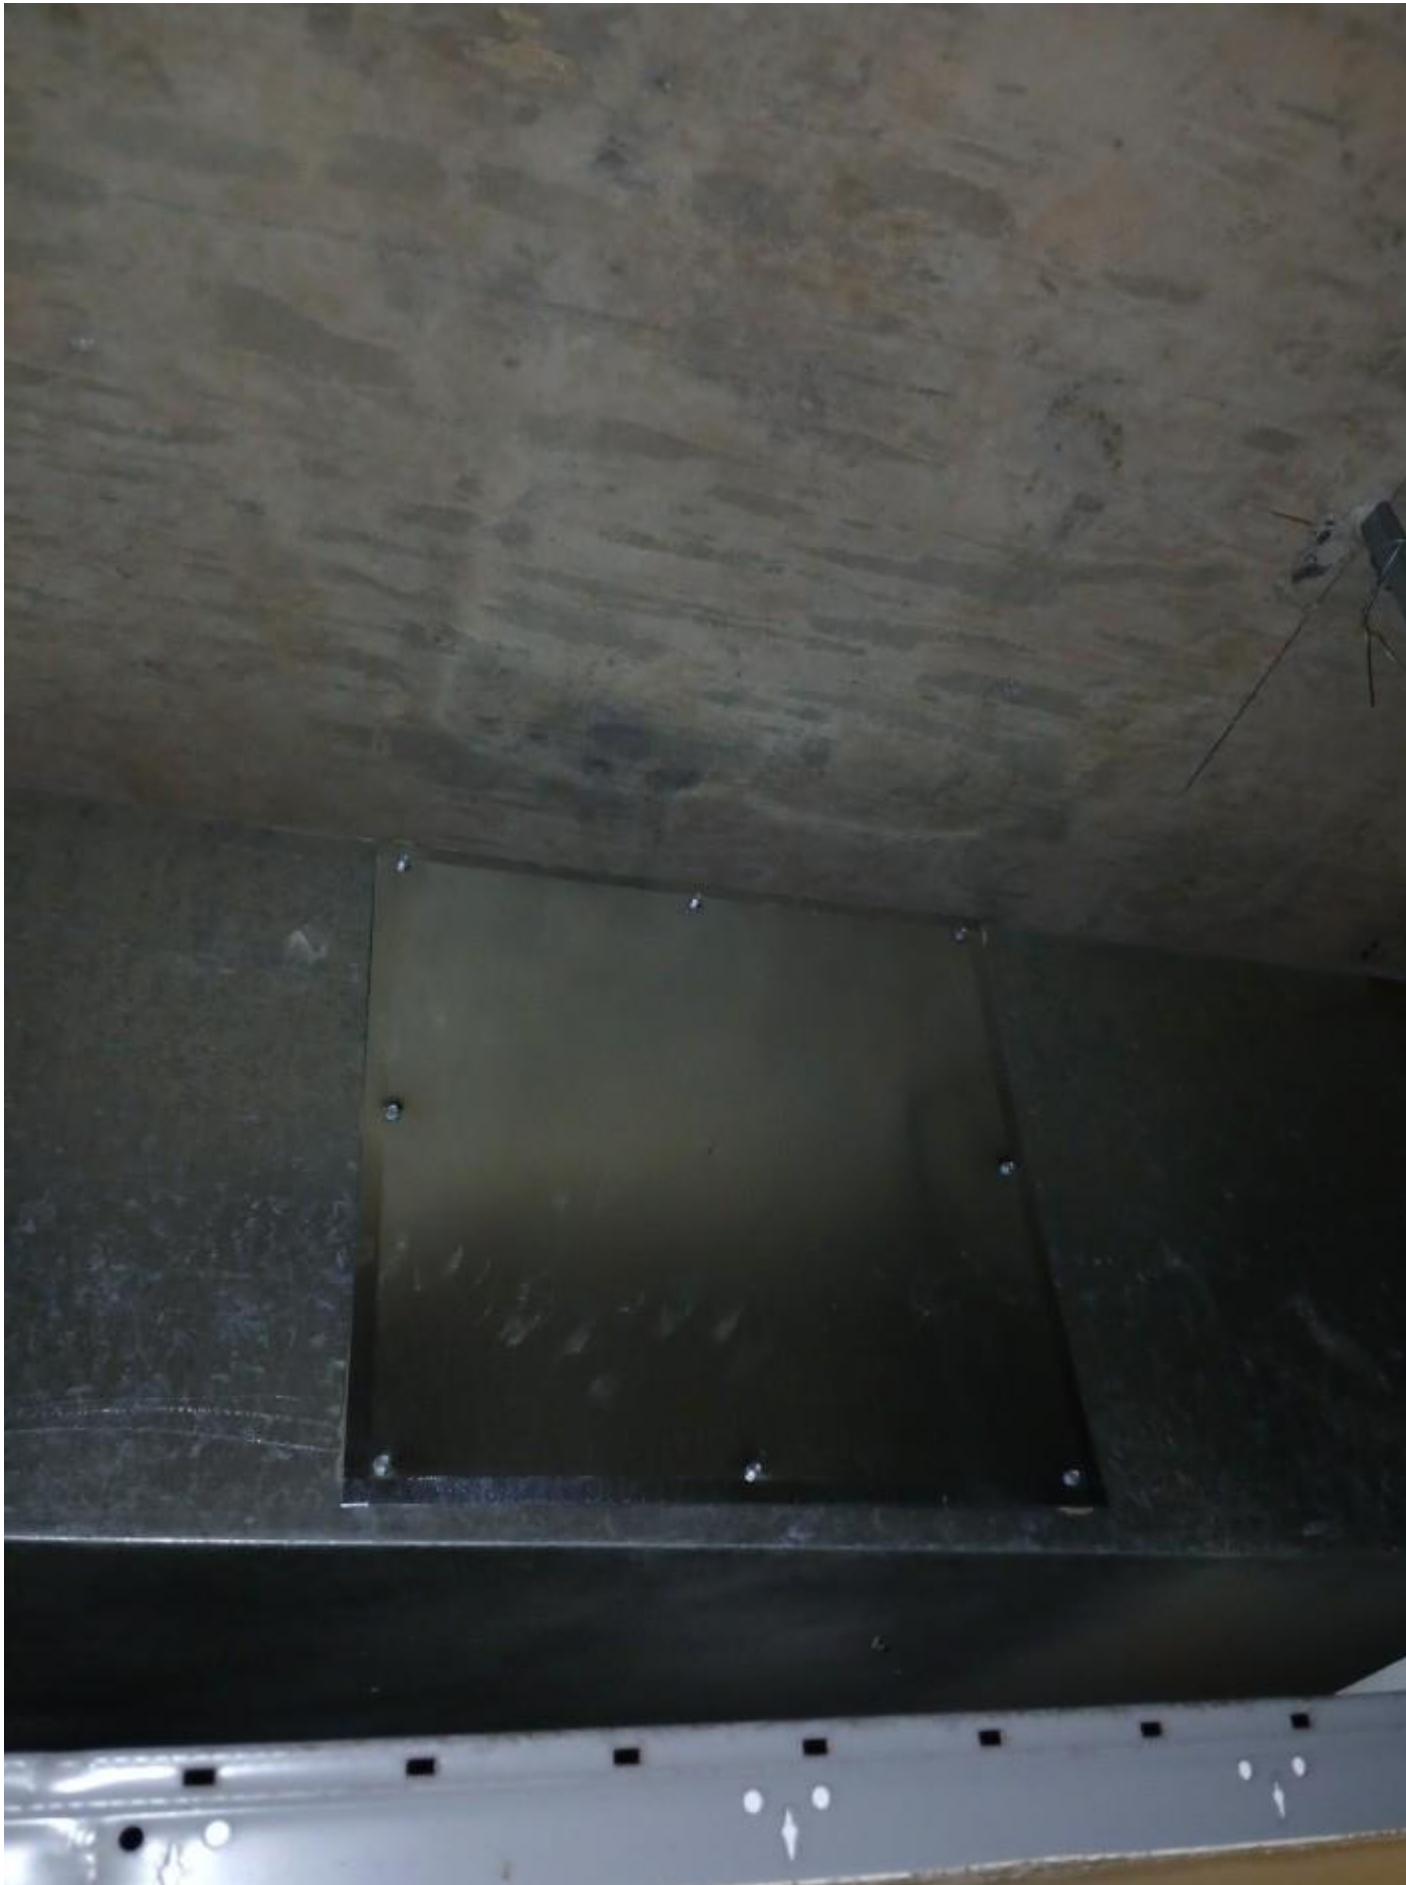
Second floor in final clean. Duct entry point covering installed and complete.
