Field Observation Report

Project: Oklahoma County Justice Center – Behavioral Care Center

Project Number:	22.09025.00	Report Number:	Sixty - 60
		Date Prepared:	04/14/2026 and 04/15/2026
		Prepared By:	Kyle Lombardo
		Date Issued:	04/17/26
		File:	Project Team Observation Reports

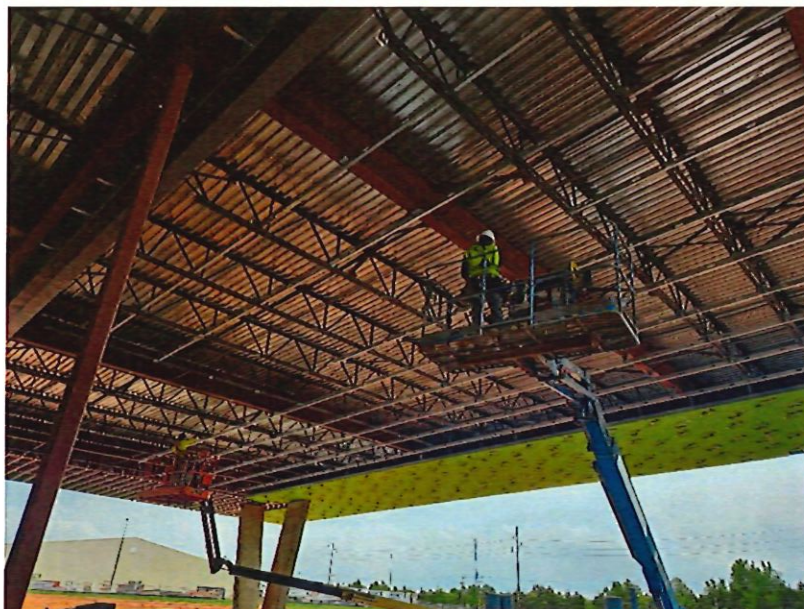
Item #60.02
(4/14/26)

Observation: **Work In Progress** – Work continues at Entry Canopy, including installation of sheathing at perimeter soffit and framing for linear metal soffit material at the center of the canopy.

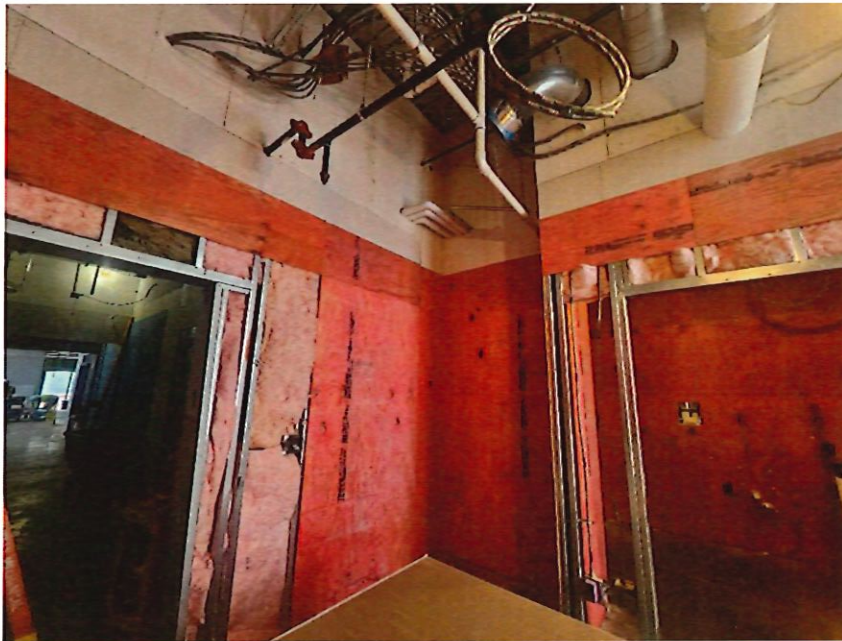
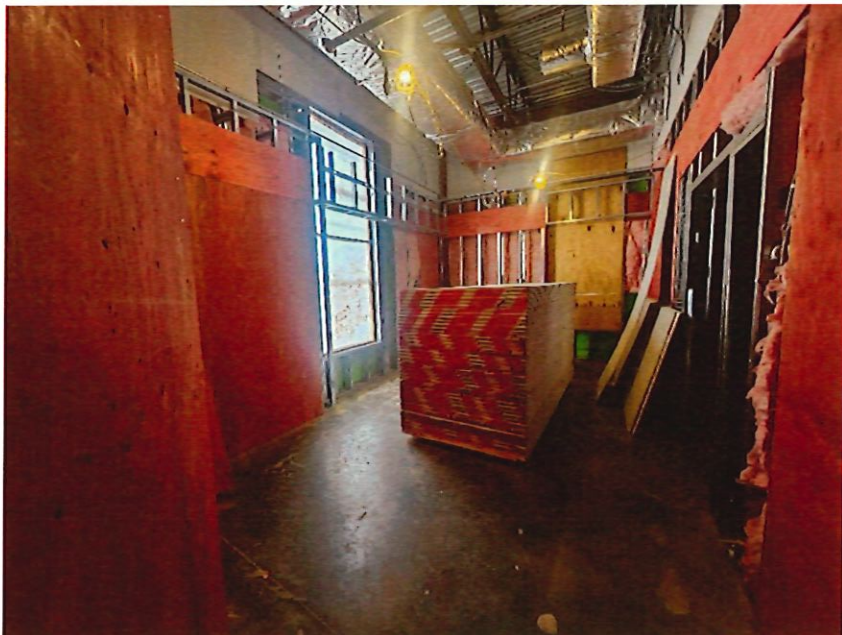
Item #60.03
(4/14/26)

Observation: **Work In Progress** – Work continues in POD 3, including installation of fire-resistant plywood backing in patient rooms at the south and west sides of the pod.

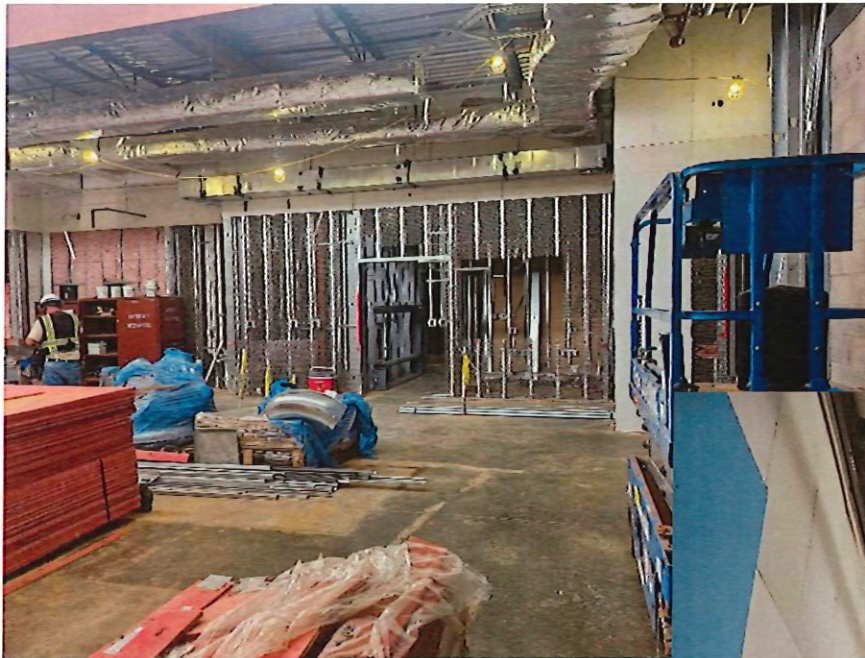
Item #60.04
(4/14/26)

Observation: **Work In Progress** – Work continues in Social Space 300, including window adjustment at Document 336 and the start of impact-resistant gypsum board installation at the west side of the space.

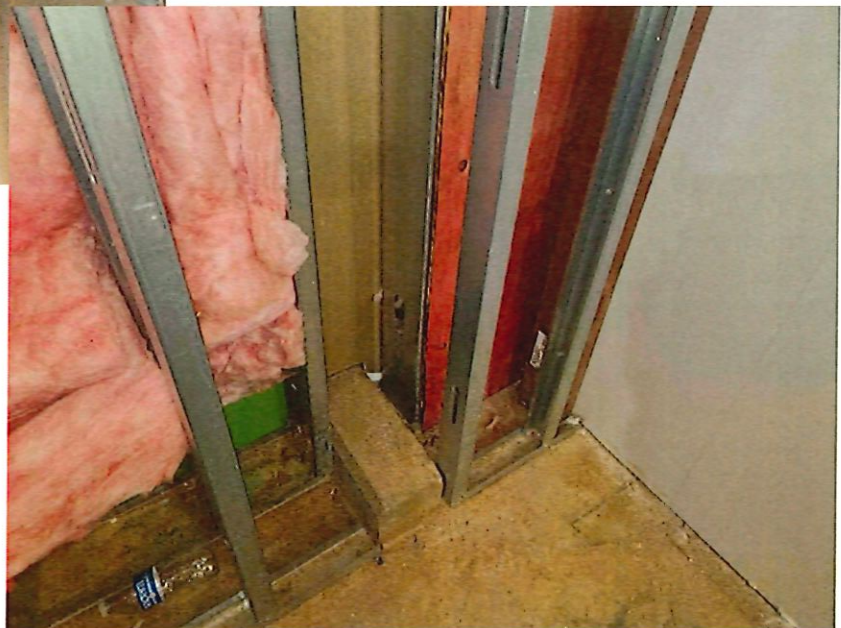
Item #60.05
(4/14/26)

Observation: **Work In Progress** – Fire-rated partition correction underway at the NW corner of Shared Patient Room 311A. Gypsum board on the corridor side of the partition now extends to exterior wall sheathing. Work continues to complete the patient room side of the wall, so it returns to the exterior wall sheathing.

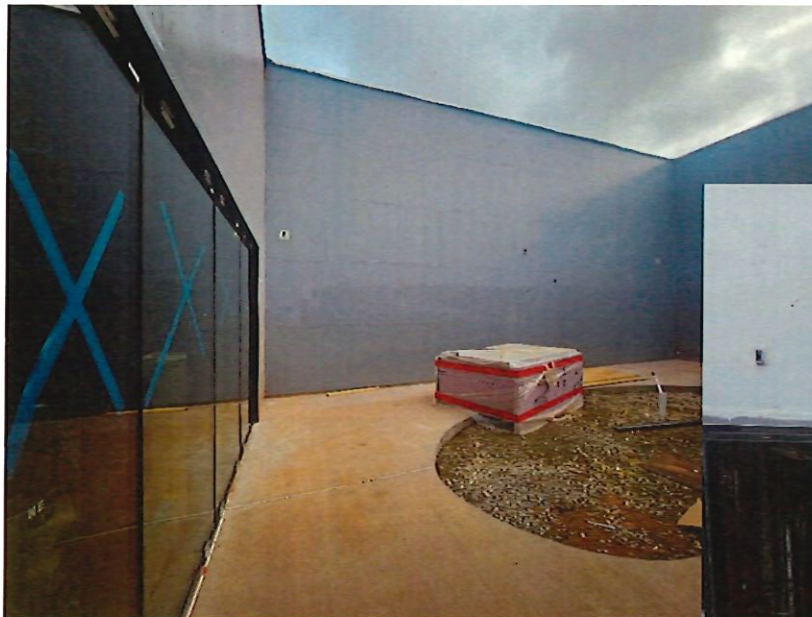
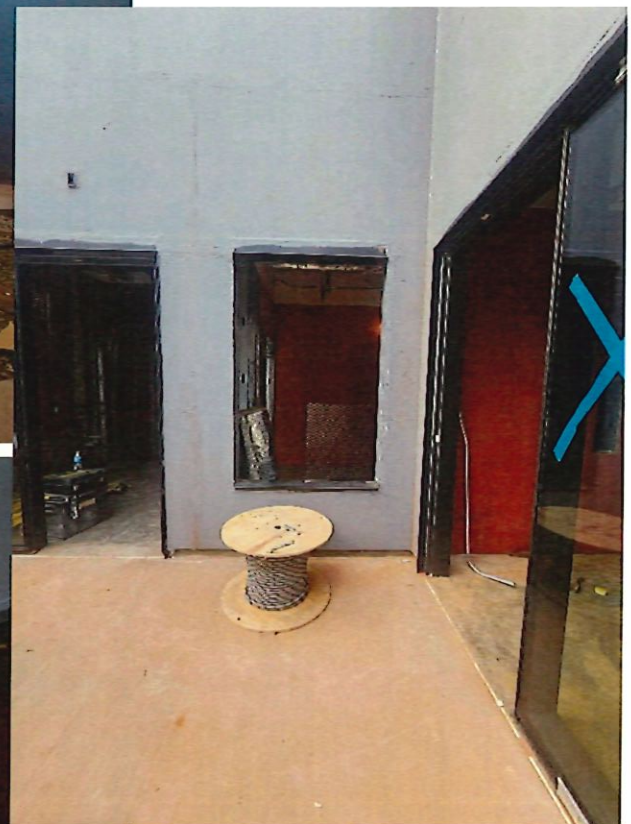
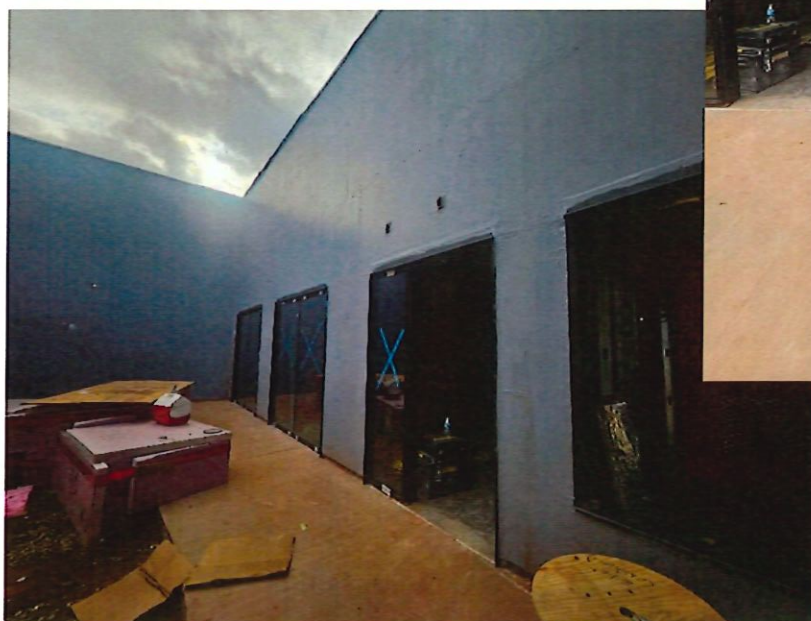
Item #60.06
(4/14/26)

Observation: **Work In Progress** – Glazing has started in all the courtyards, and caulking of the frames is underway.

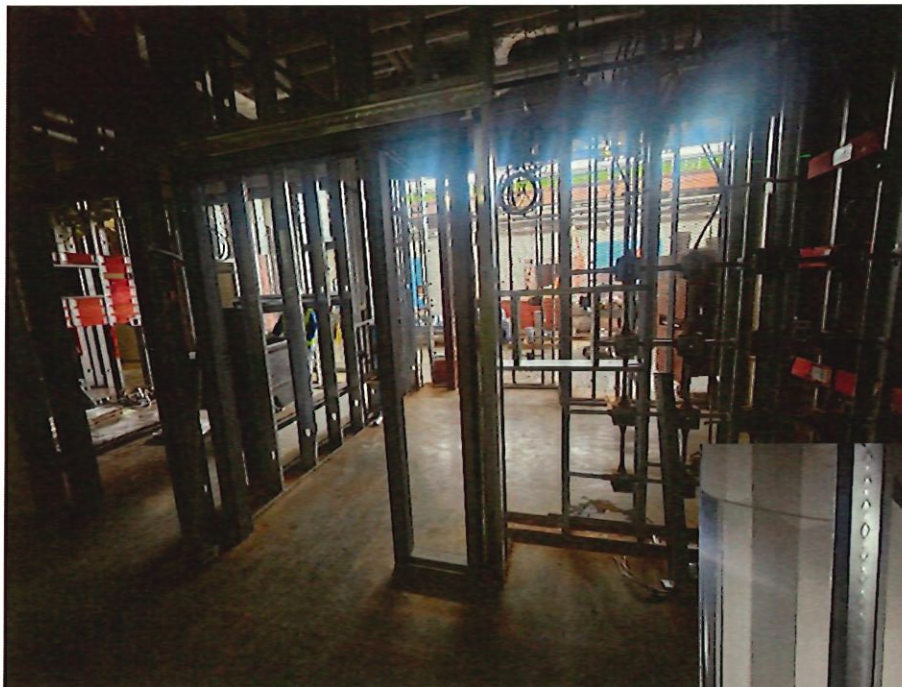
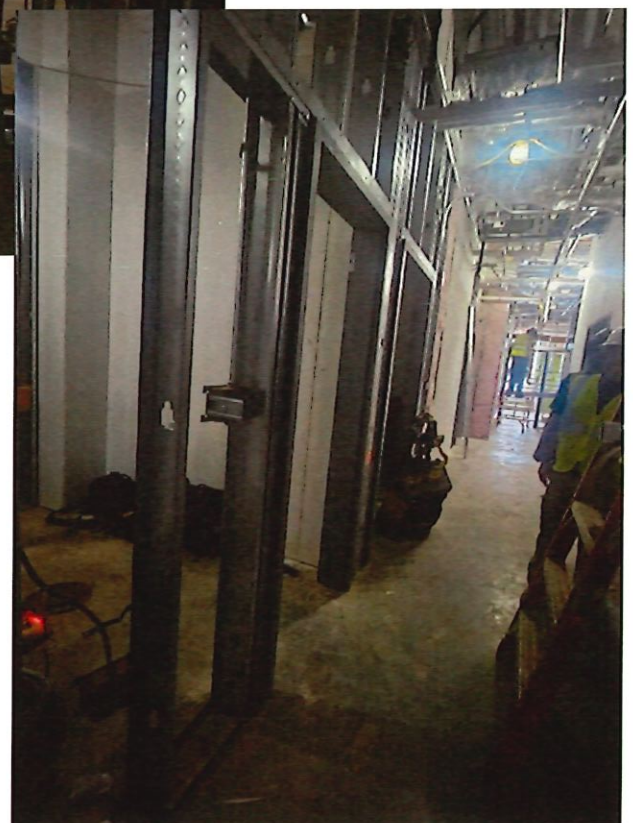
Item #60.07
(4/14/26)

Observation: **Work In Progress** – Hollow metal door frames are being installed in various locations throughout the building, including in Corridor 339B.

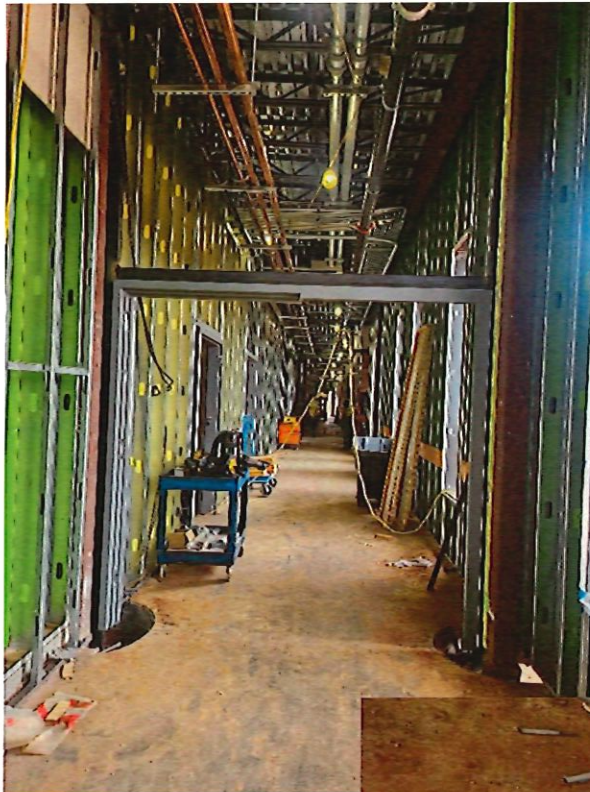
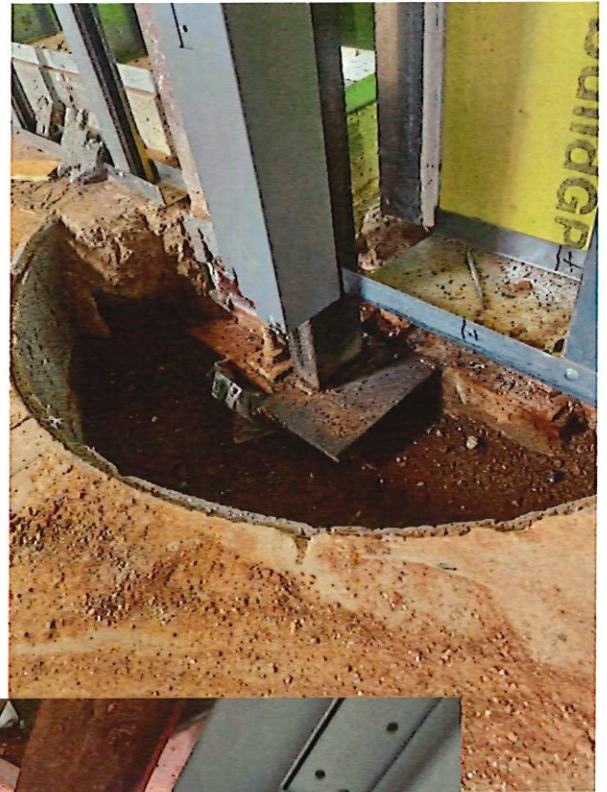
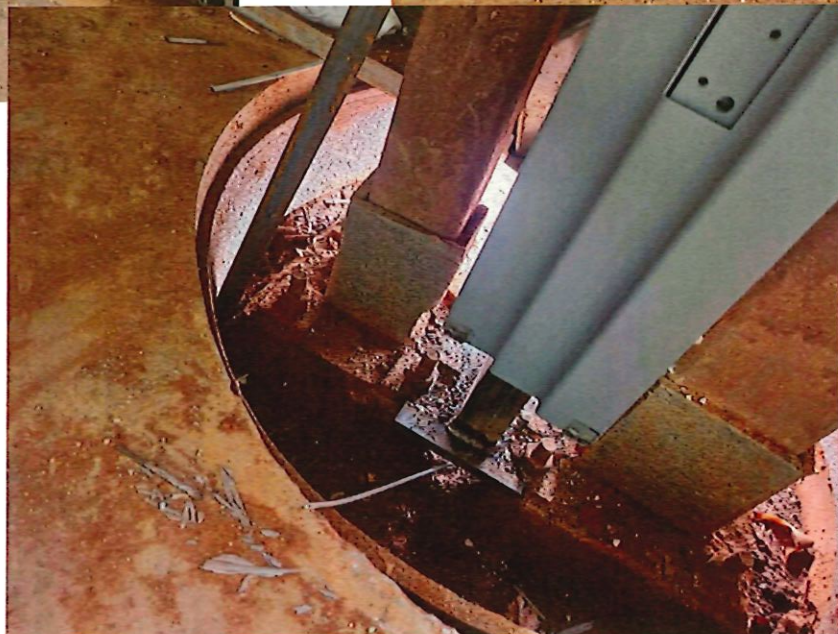
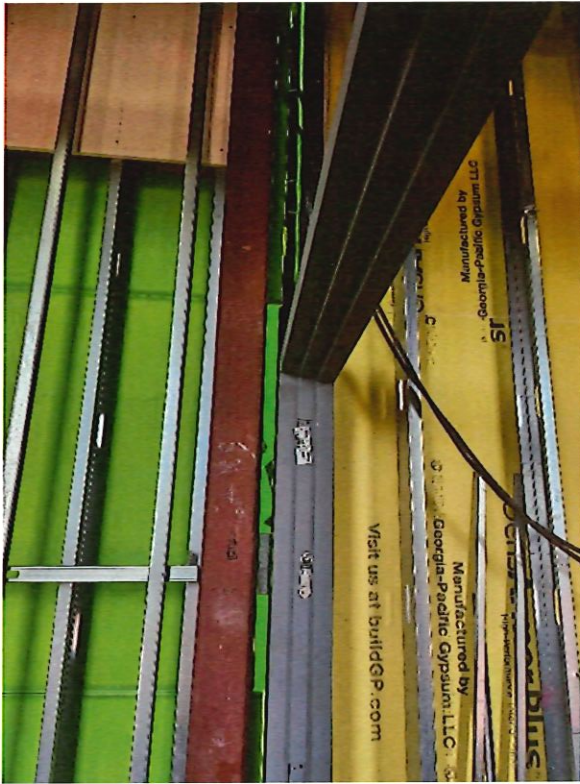
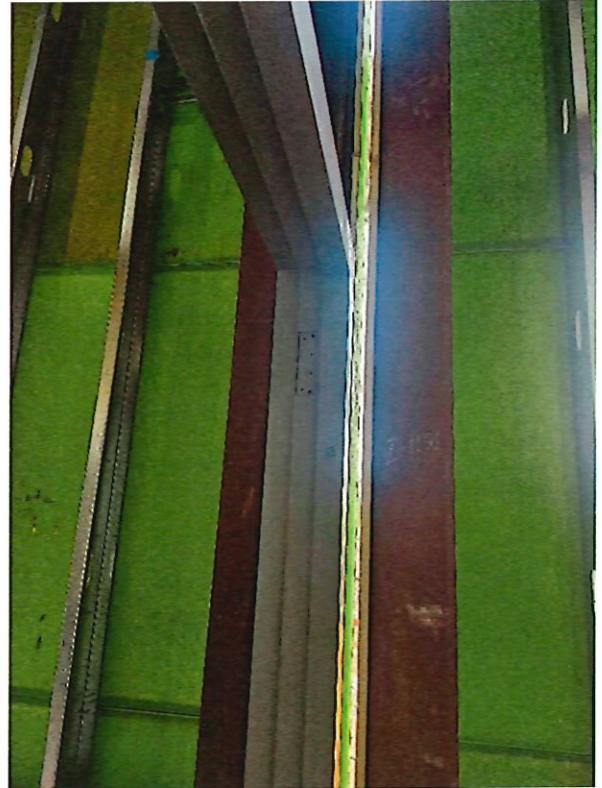
Item #60.08
(4/14/26)

Observation: **Work In Progress** – Hollow metal door frame at door 006B installed, including tube metal frame and welded connections to column base plates on grid 9B.2 on the south side of the expansion joint.

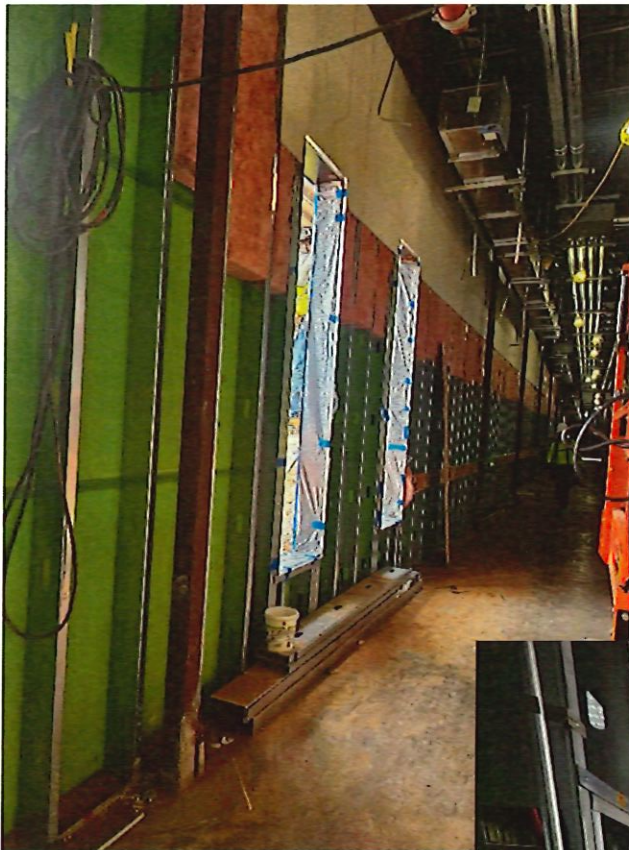
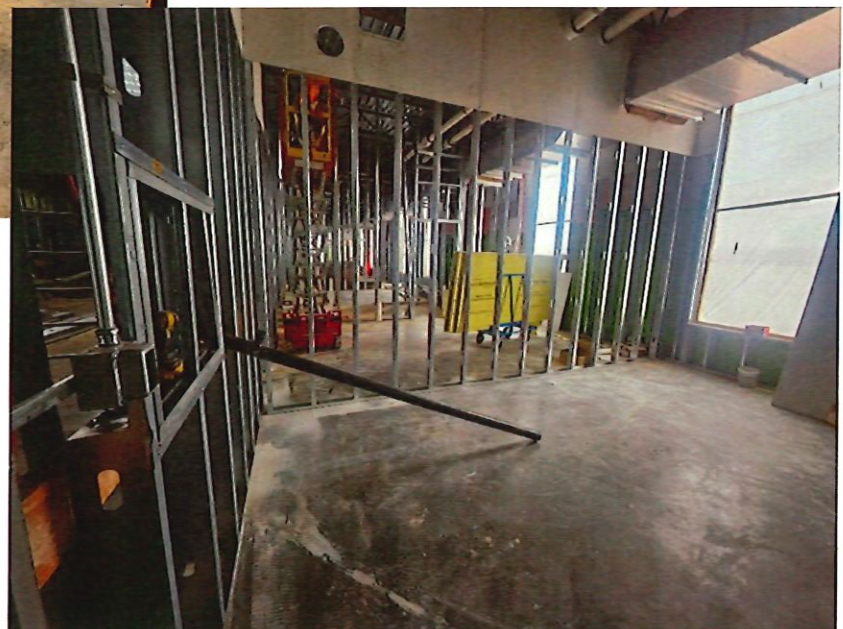
Item #60.09
(4/14/26)

Observation: **Work In Progress** – Work continues in Pod 1, including skirting and insulation at the west wall of Corridor 006A and at patient rooms along the east side of the pod.

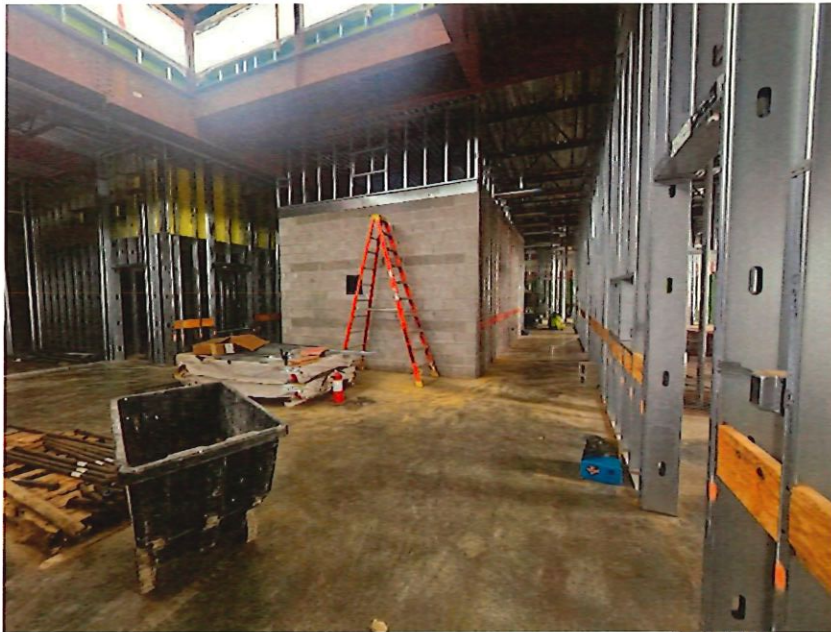
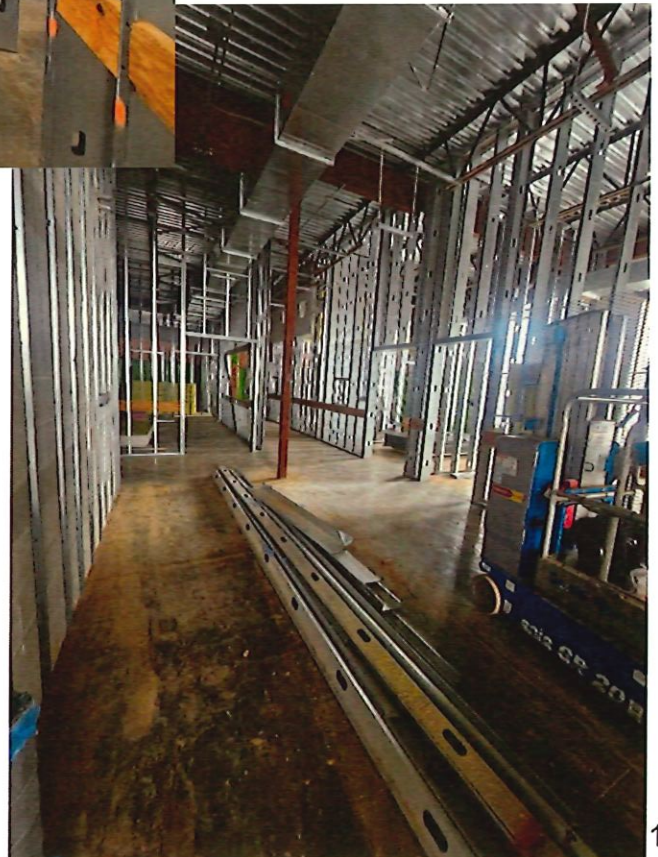
Item #60.10
(4/14/26)

Observation: Work In Progress – Work continues in Social Space 100, including mechanical piping configuration, plumbing, interior framing, and handrail blocking installation.

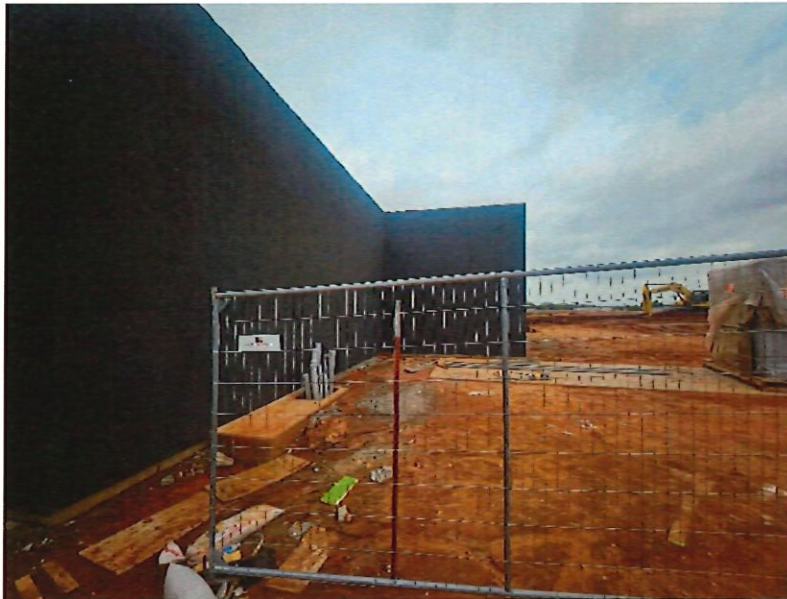
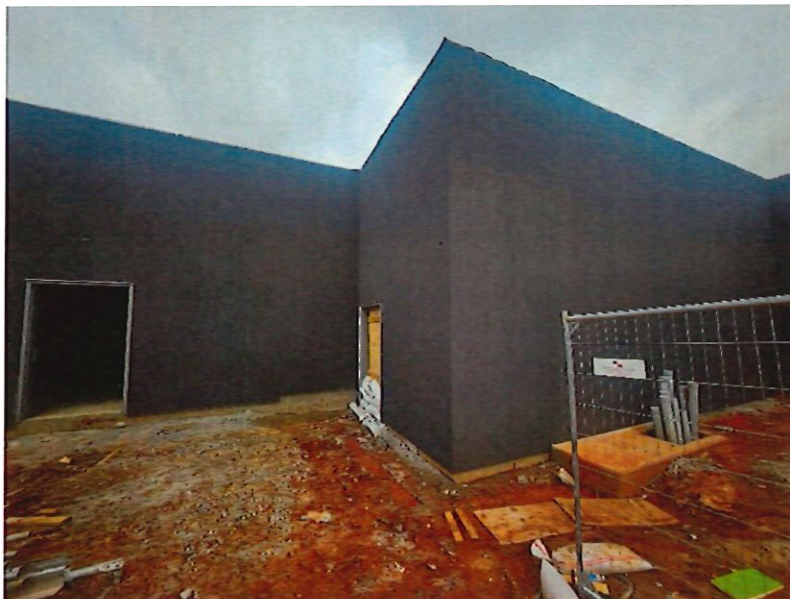
Item #60.11
(4/14/26)

Observation: **Work In Progress** – Plaster finish nearing completion at the east side of the connector Area X, adjacent to the generator set location.

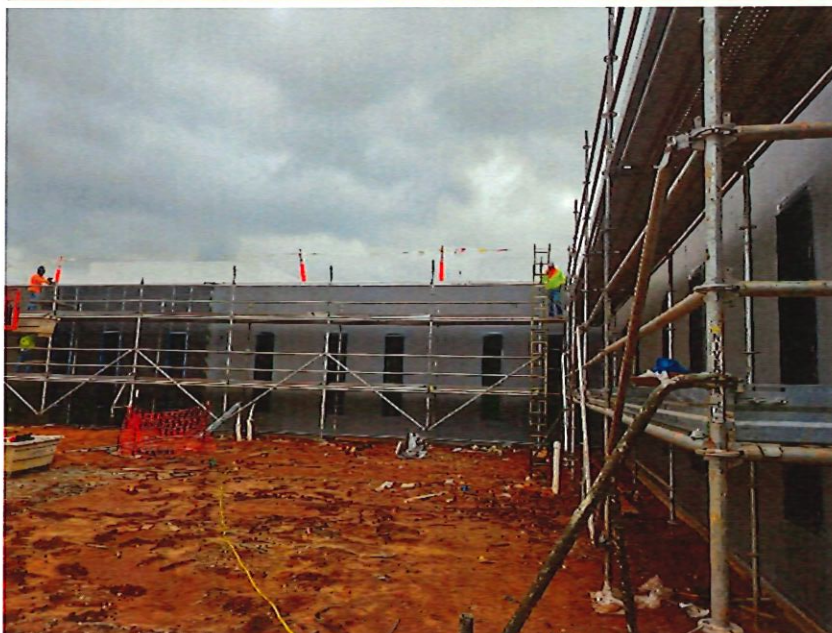
Item #60.12
(4/14/26)

Observation: **Work In Progress** – Plaster work continues at the west side of Pods 1 and 2, including plaster work in each stage of the installation process.

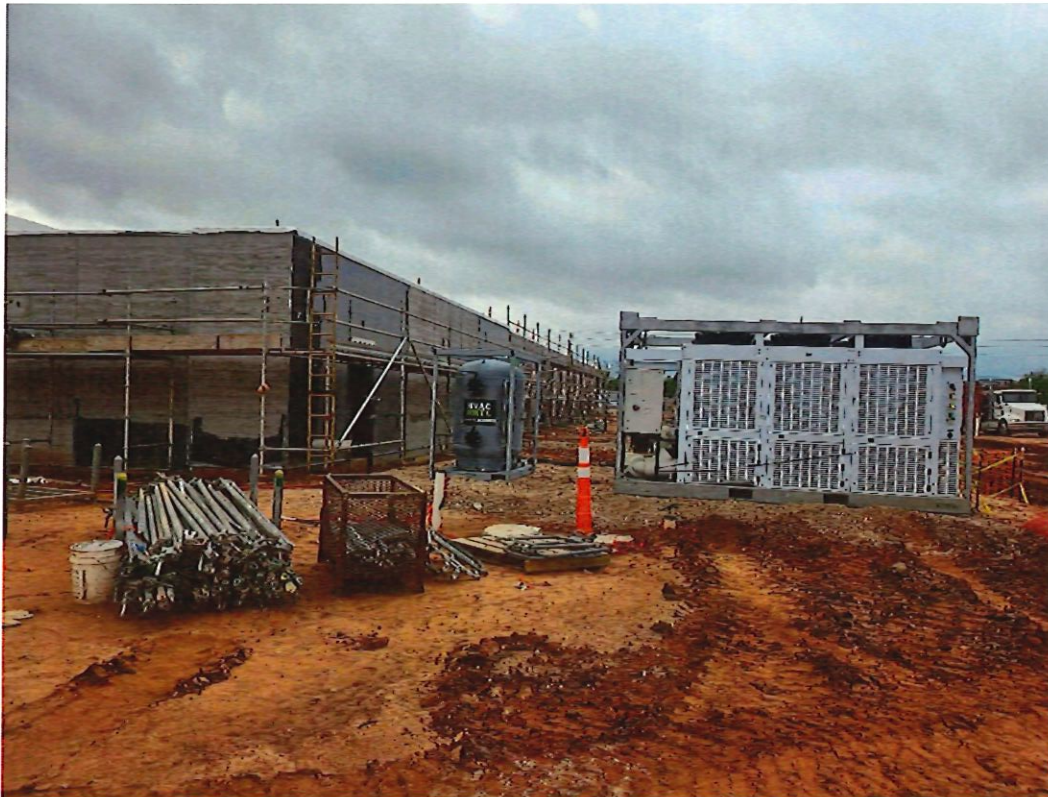
Item #60.14
(4/14/26)

Observation: **Work In Progress** – Temporary chiller located outside Mechanical Room 011A, awaiting hookup to provide temporary air conditioning to Pod 3 and Administration areas.

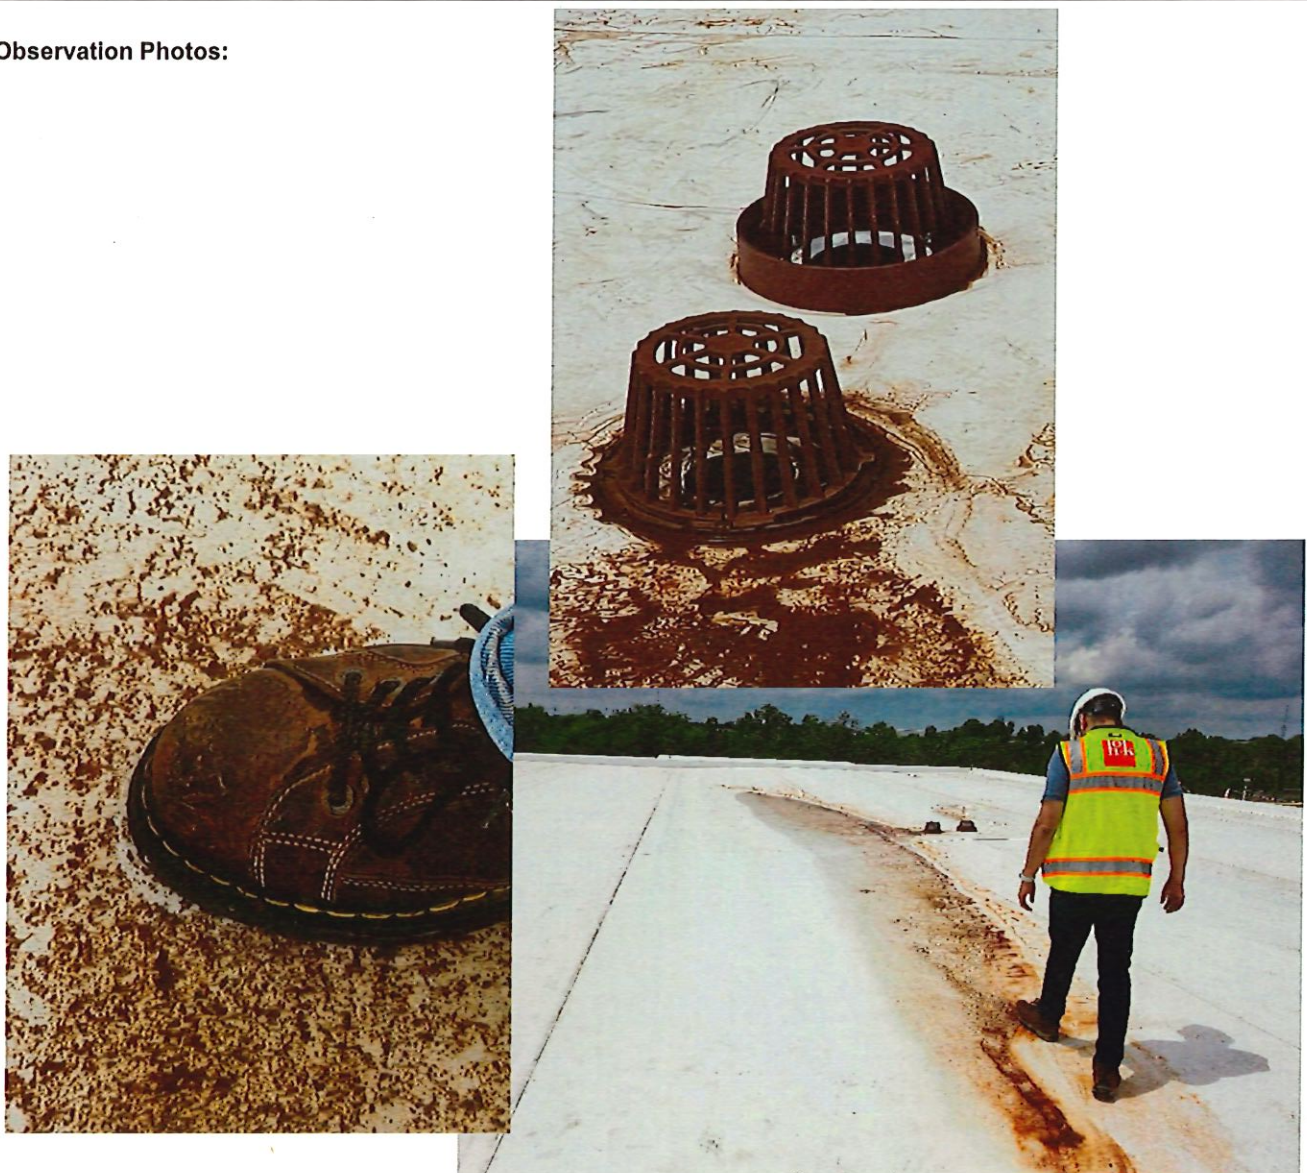
Item #60.15
(4/14/26)

Observation: **Work In Progress** – Roof membrane complete at Entry Canopy. Approximately 5/8" deep area of ponding just south of the roof drain due to a high spot in the roof insulation.

The roof membrane at the roof drains appears to have been cut approximately 3" smaller in diameter than the mouth of the roof drain assembly.

- A. Make repairs per 075423 – 3.10.H to eliminate ponding located south of the roof drain. Confirm roof slope meets requirements of 075423 – 2.5.D.3.a and b.
- B. Adjust the diameter of the hole in the roof membrane at the roof drains to match the roof drain assembly. Confirm installation meets Oklahoma Uniform Building Code Commission Rule 748:20-16-16

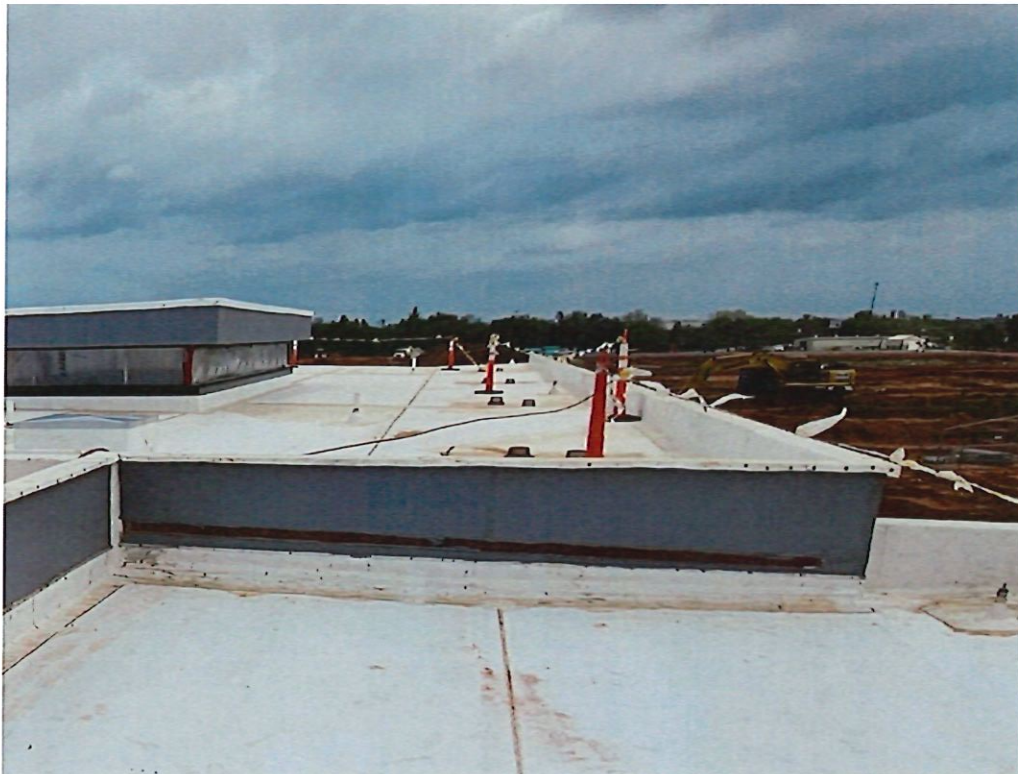
Item #60.16
(4/14/26)

Observation: **Work In Progress** – Section of structural steel appears to be exposed and interrupting the continuous plane of the air barrier/rain screen at the north parapet wall of the low roof over mechanical Room 010A.

Action Items: A. Confirm air barrier and installation meet the requirements and the intent outlined in 072726-2.2.A, 072726-3.2.H, and 072726-3.4.A.

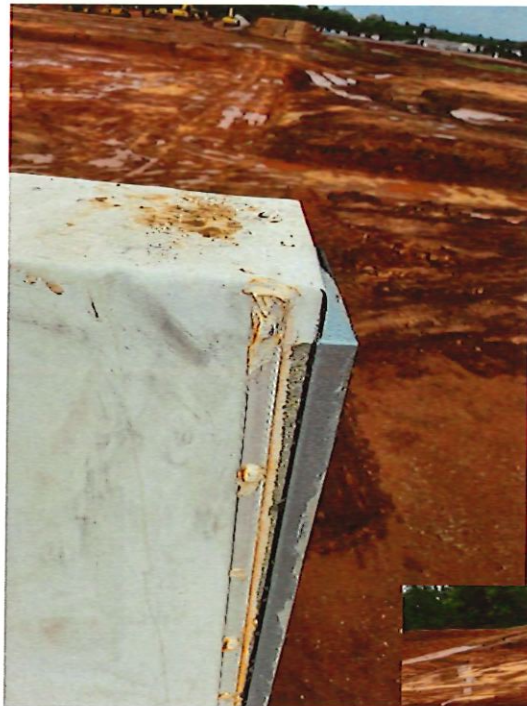
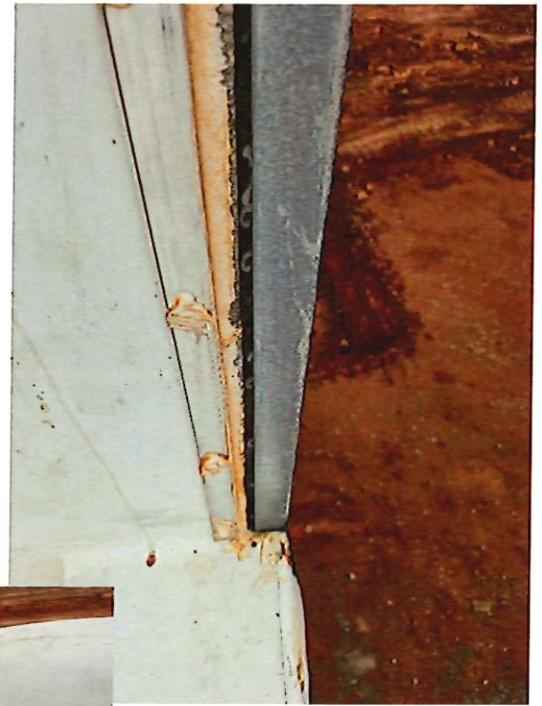
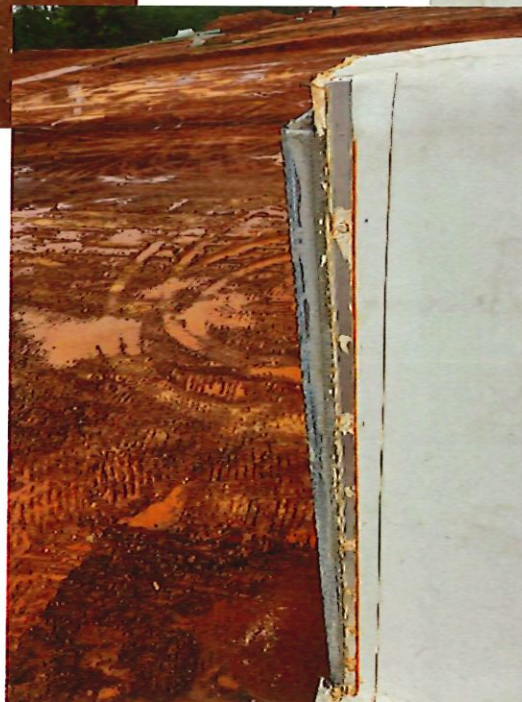
Item #60.17
(4/15/26)

Observation: Work In Progress – Plaster finish covering exposed ends of CMU has created a vertical joint between the plaster and the CMU.

Action Items: A Flintco to ask the certified Carlisle installer about a warrantable membrane flashing strip solution to cover the joint.
