# Field Observation Report

## Project: Oklahoma County Justice Center – Behavioral Care Center

Project Number: 22.09025.00

Report Number: Sixty-Eight - 68

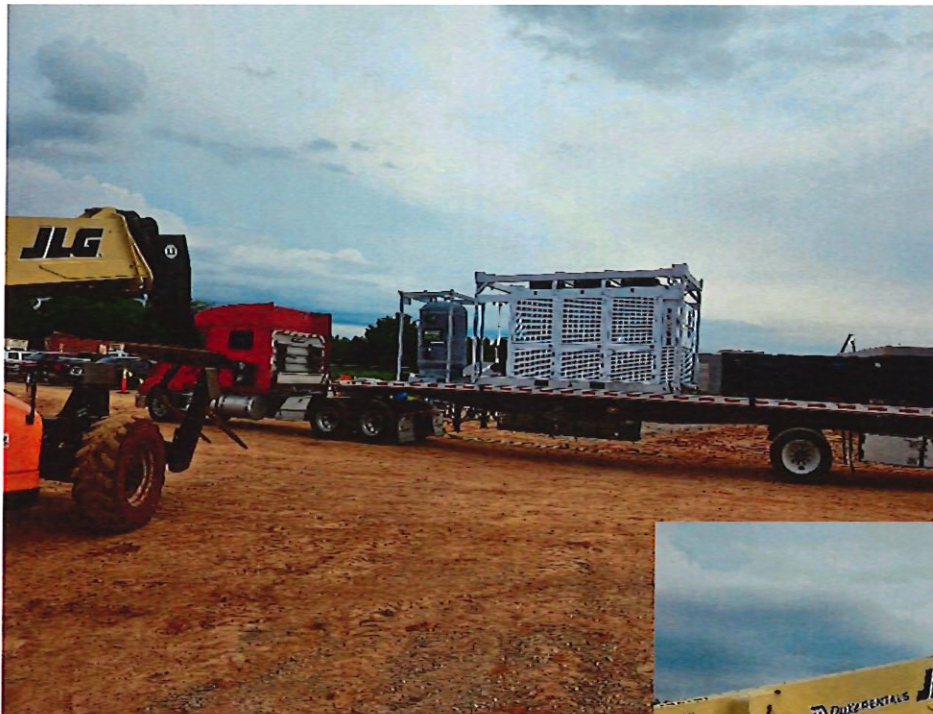
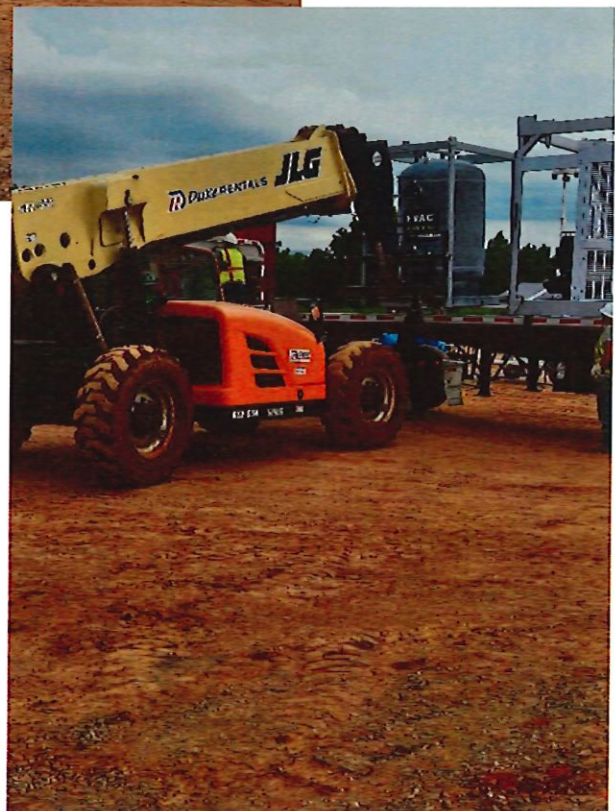
**Item #68.01**  
**(6/2/26)**

**Observation:** Work In Progress – Temporary chiller number two arrives at site and awaits hook-up.

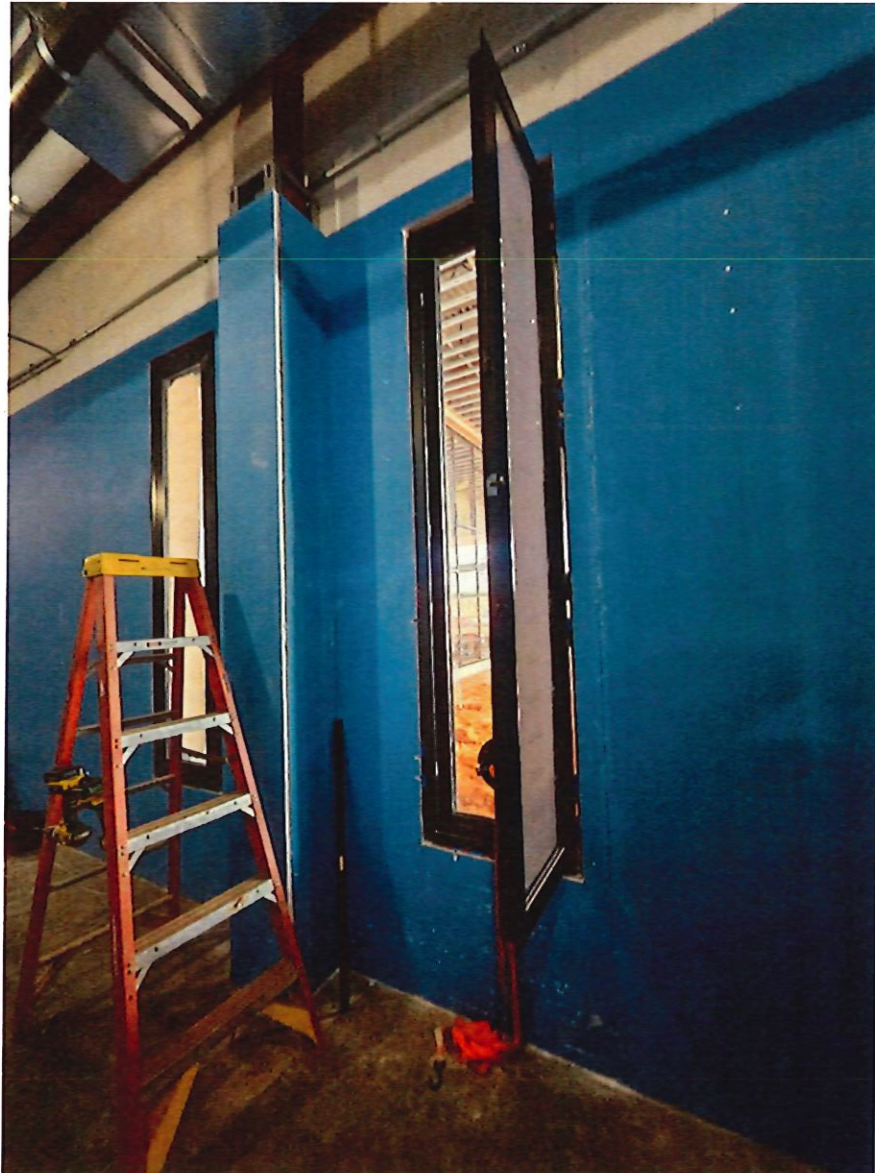
Item #68.02  
(6/2/26)

**Observation:** Work in Progress – Windows in Secure Corridor 006E are being adjusted after installation.

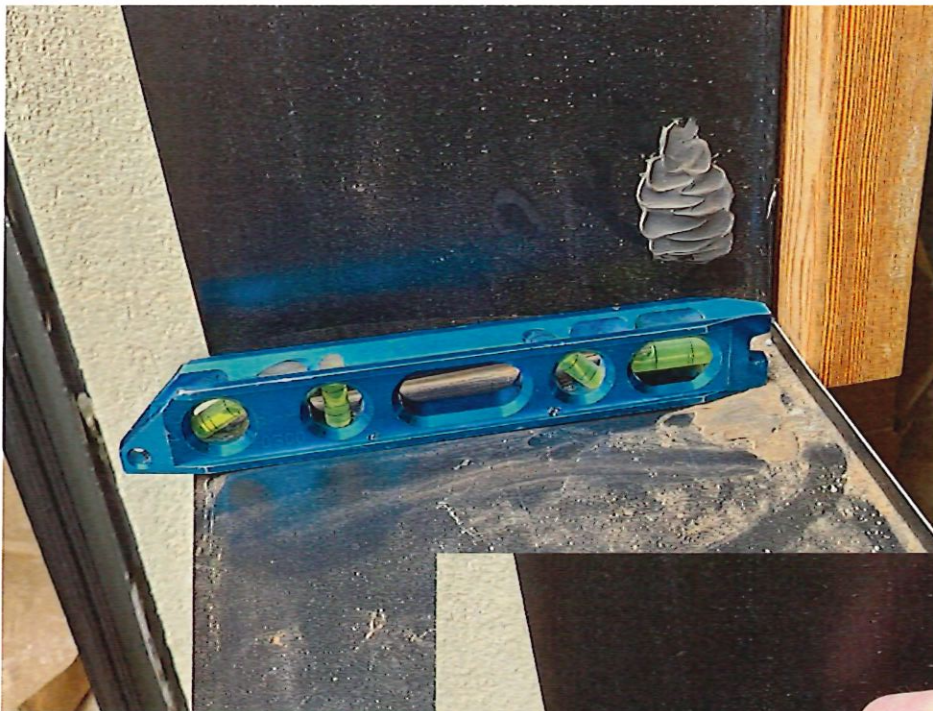
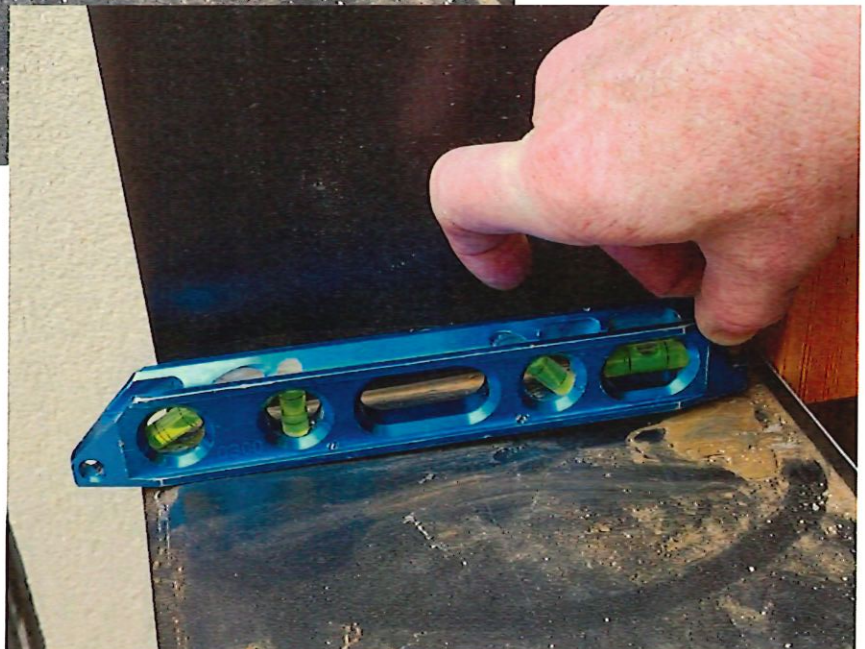
**Item #68.03**  
**(6/3/26)**

**Observation:**        **Work In Progress** – Several sills at the break metal surrounds at the windows were observed to slope inward toward the building rather than outwardly as shown on the drawings.

- Action Items:**
- A. Provide shimming of the sills from the interior of the building to provide each window sill a positive slope away from the interior of the building as indicated in the details shown on sheet A333 of the drawings.
  - B. Construction photos for review with the As-Built documents showing correction should be provided (013233-1.6- G.3.e).

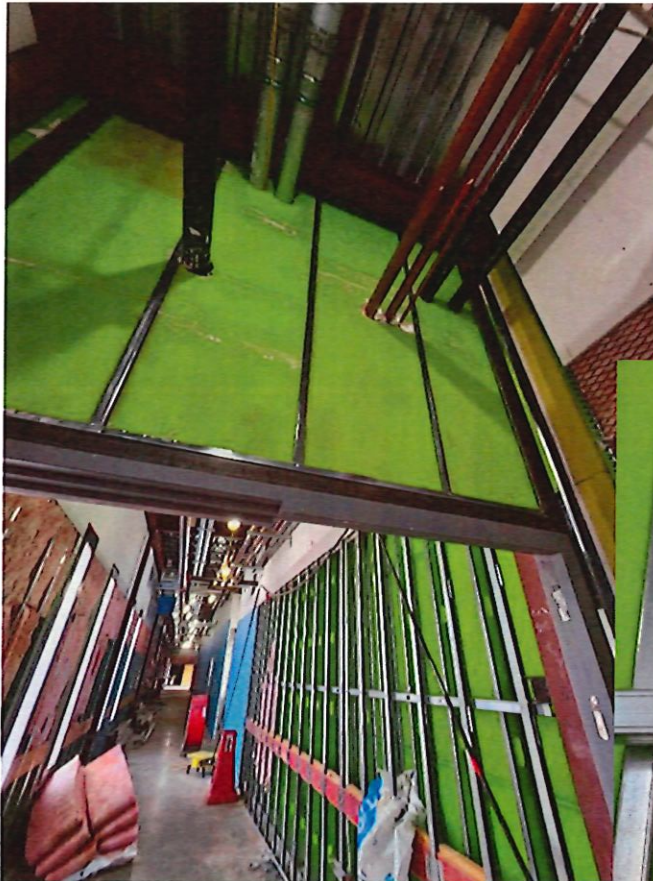
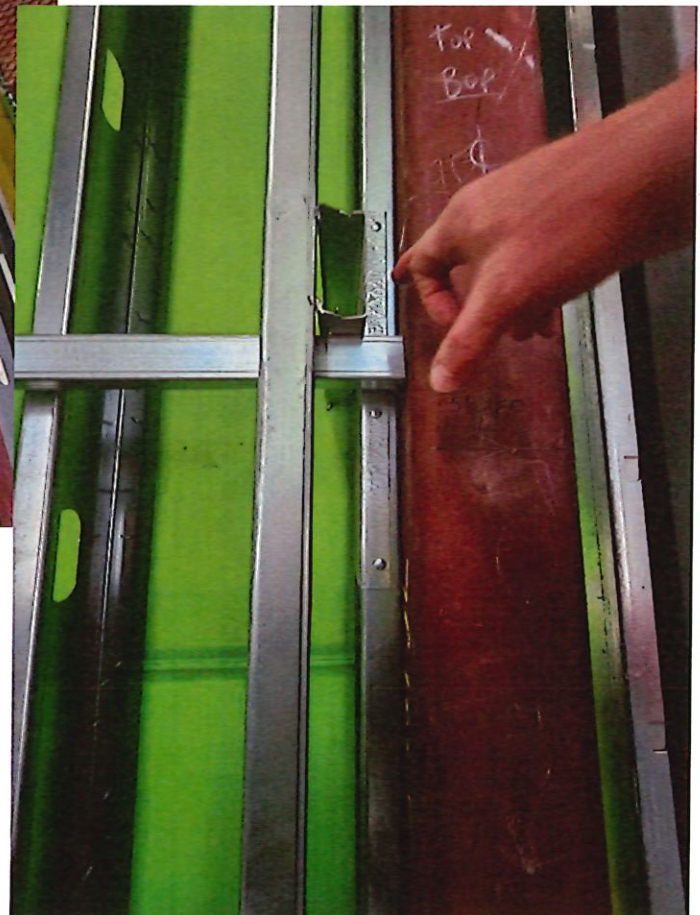
**Item #68.04**  
**(6/2/26)**

**Observation:** Work In Progress – 2-hour wall above door 006B appears to be installed per UL347, shown on sheet G005.

**Action Items:** A. Confirm details shown on sheet A802 are followed with respect to other areas associated with the UL347 wall installation.

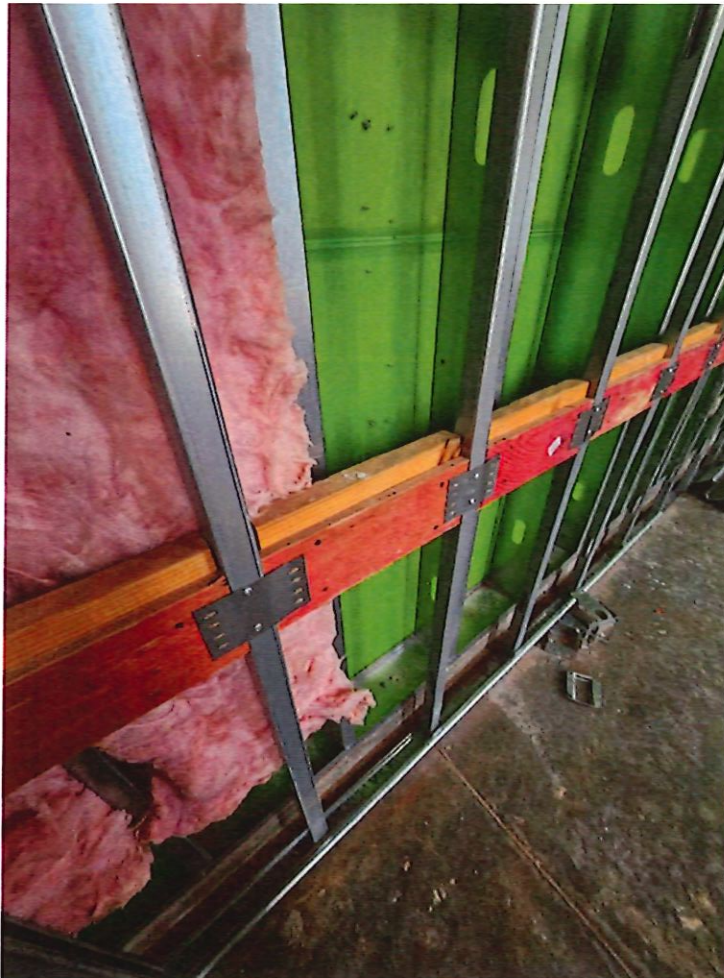
**Item #68.05**  
**(6/2/26)**

**Observation:**        **Work In Progress** – Corridor handrail backing at the east wall north of door 006 appears to be weak in the direction perpendicular to the length of the wall. Deviation from the method of blocking installation in other areas appears to be related to the 1 5/8" furring being used in this area.

**Action Items:**        A. Demonstrate blocking stability in the weak direction before covering the blocking with plywood, mesh, or gypsum board.

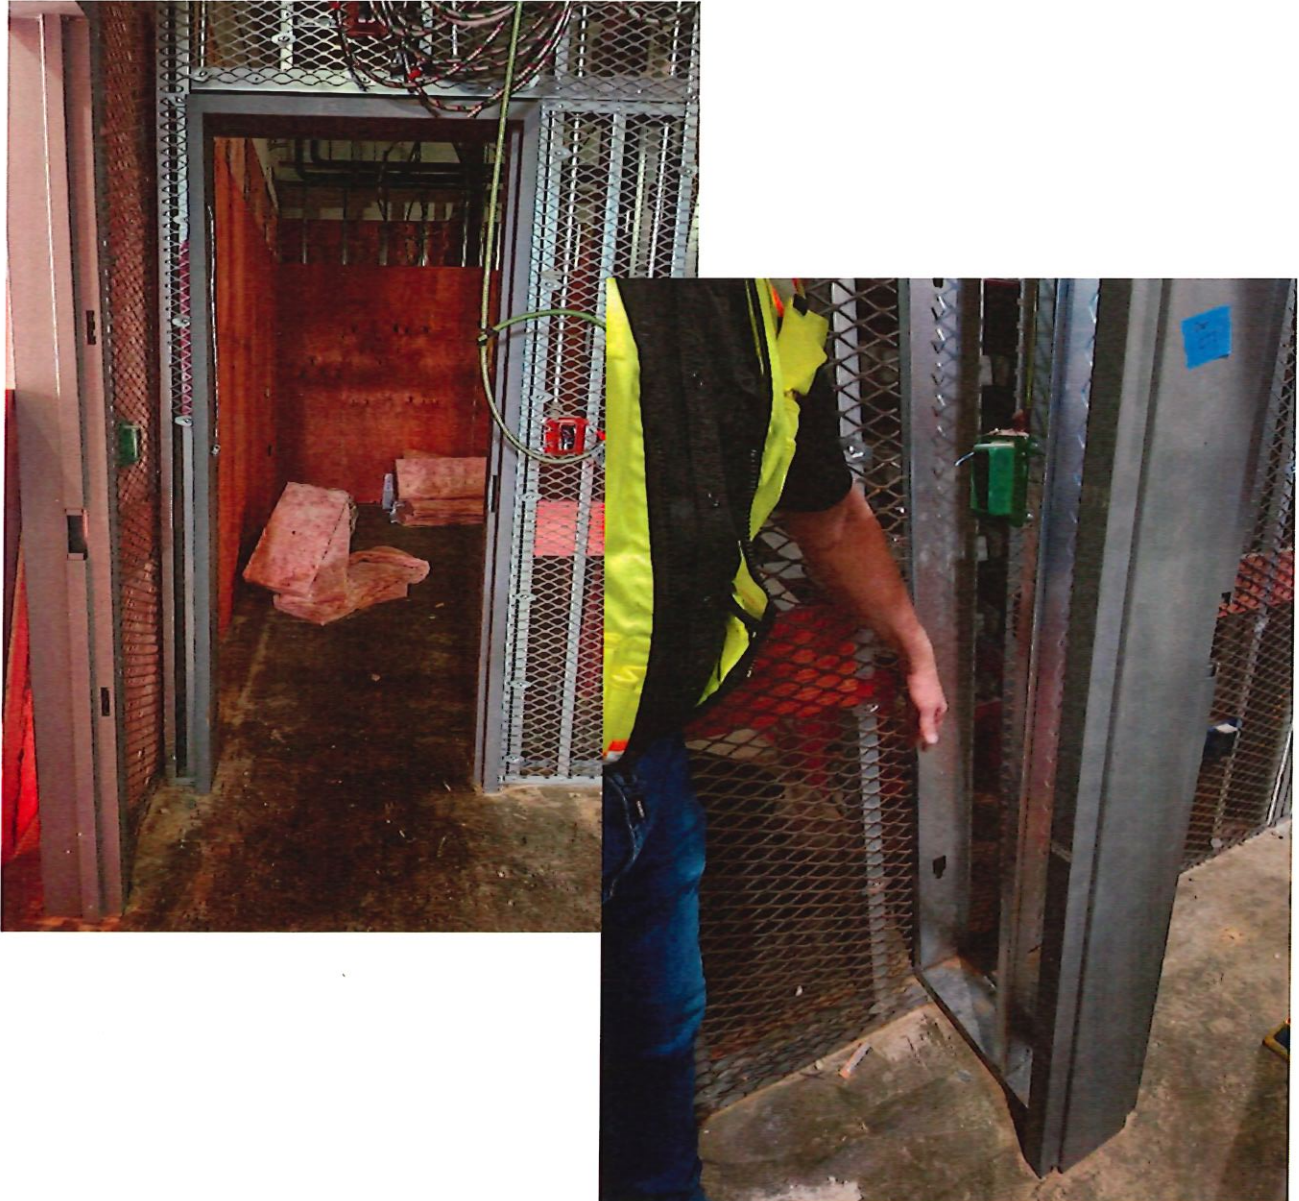
**Item #68.06**  
**6/2/26)**

**Observation:**        **Work in Progress** – Review of security mesh and header clips at doors in Pod 2 includes areas where mesh has been loosened to afford the access needed to install hardware wiring pathways. These conditions are part of the scheduling process of the work and are being corrected as the work continues.

**Action Items:**        A. Flintco has requested a walk-through of Pod 2 on 6-4-26 to look at the door heads and security mesh at each door opening in the secure area of the pod.

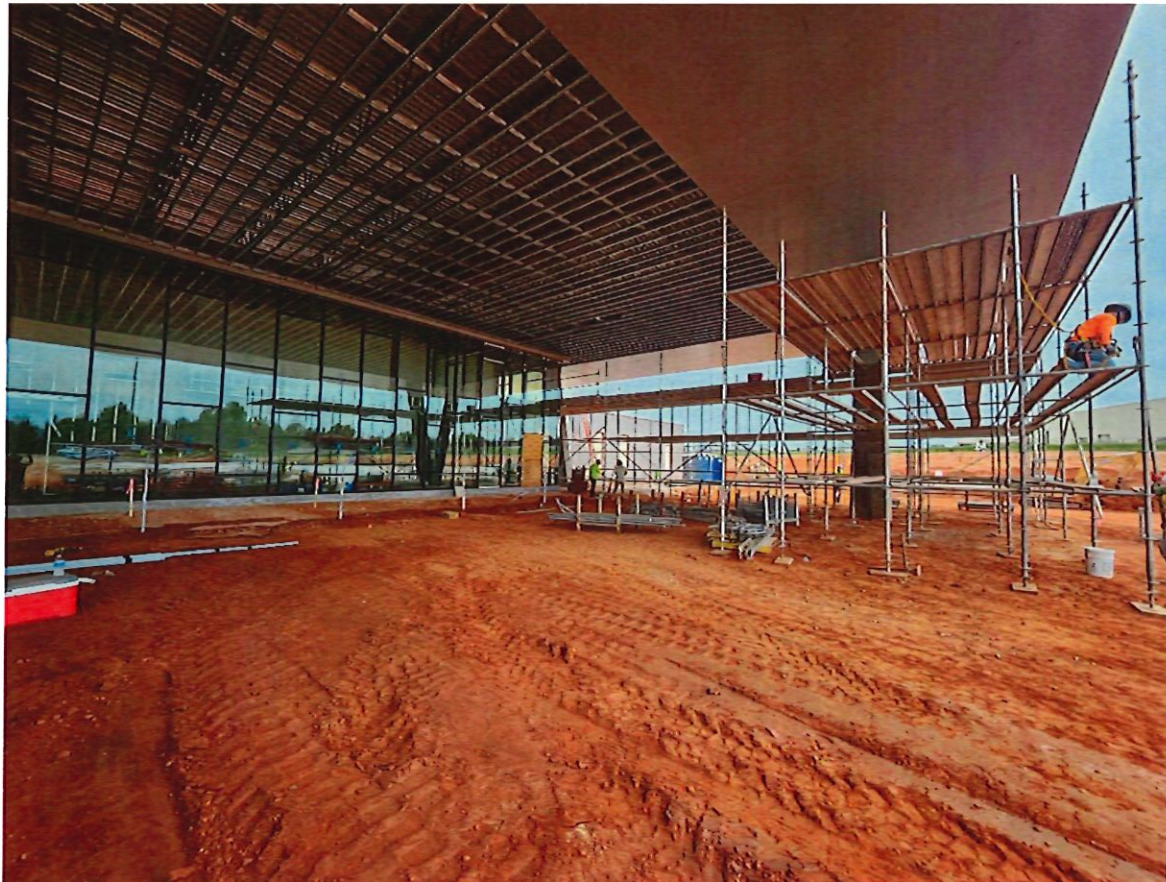
**Item #68.07**  
**(6/3/26)**

**Observation:**        **Work In Progress** – Scaffolding being assembled to start installation of cement plaster soffit at entry canopy.

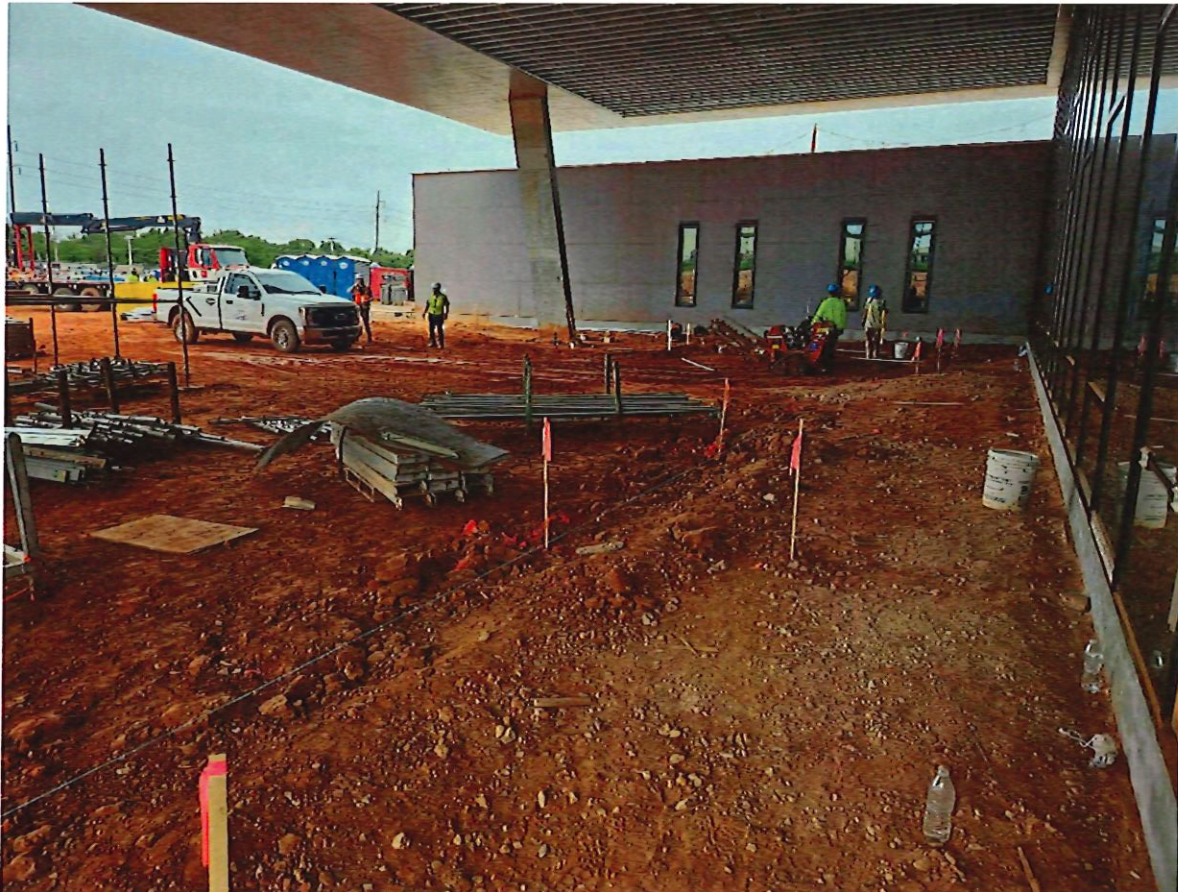
**Item #67.08**  
**(6/3/26)**

**Observation:** Work in Progress – Trenching underway for electrical service to bollards located under the canopy.

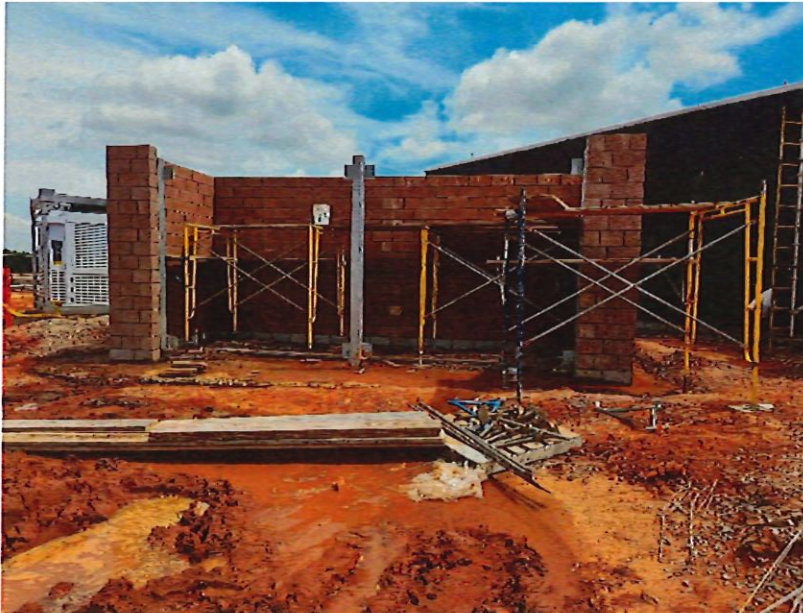
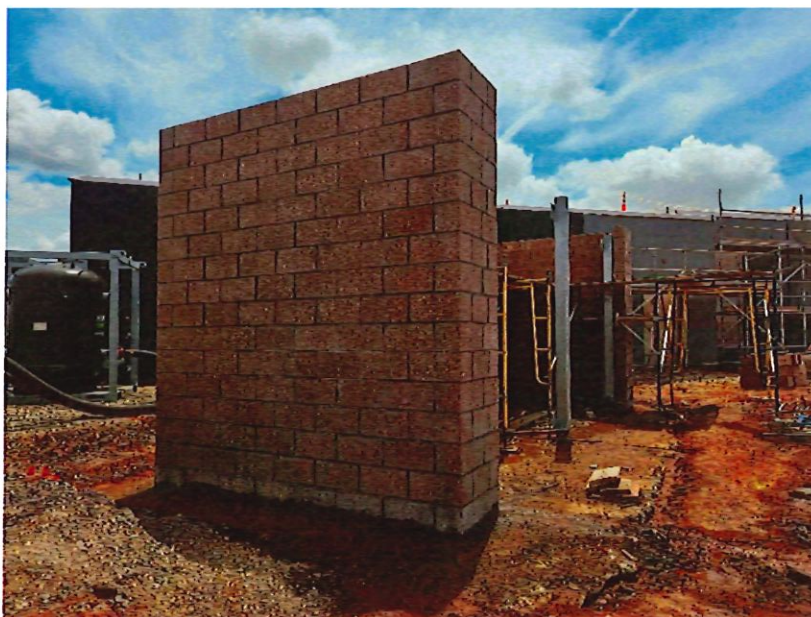
**Item #68.09**  
**(6/3/26)**

**Observation:** Work In Progress – Dumpster enclosure complete, including galvanized framing for the gates.
