# Field Observation Report

## Project: Oklahoma County Justice Center – Behavioral Care Center

Project Number: 22.09025.00

Report Number: Sixty - 60

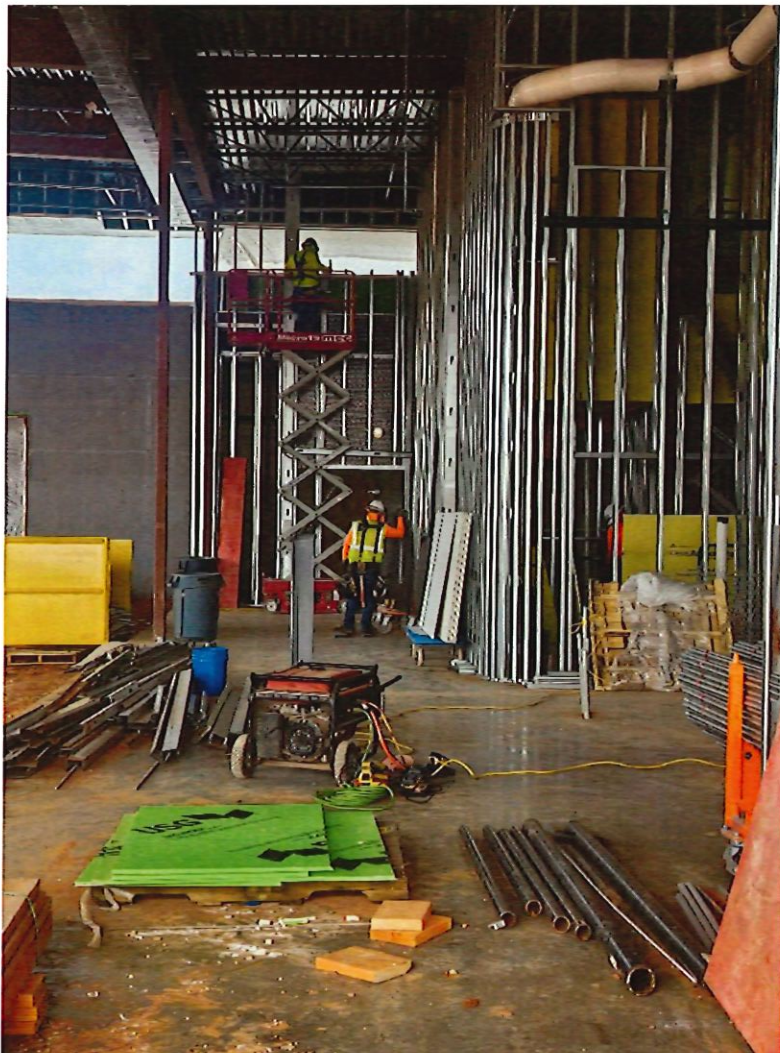
**Item #60.01**  
**(4/14/26)**

**Observation:**      **Work In Progress** – Work underway to uncover the clerestory at the west wall of Public Circulation 021B over door 021B.

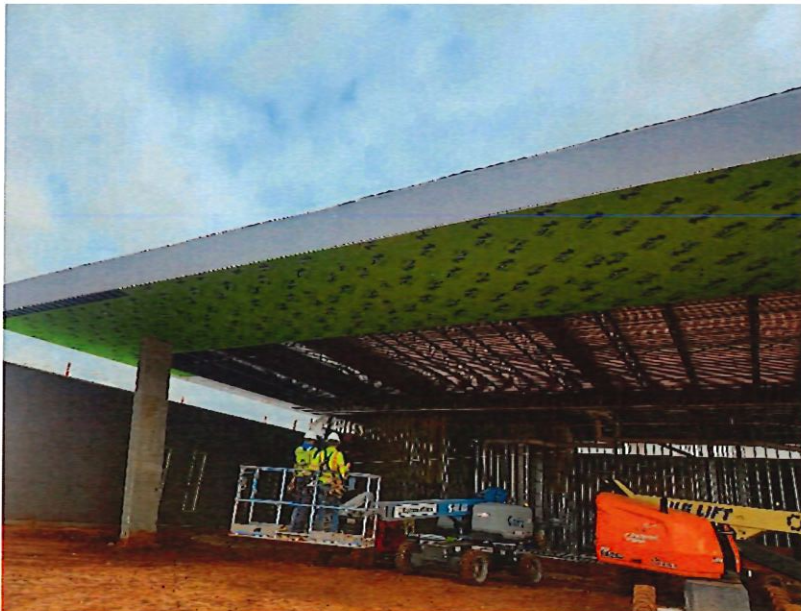
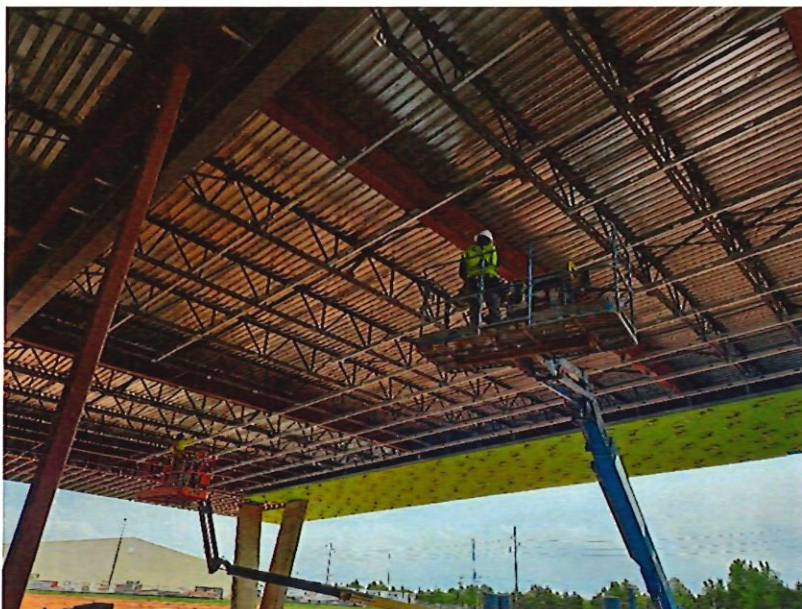
Item #60.02  
(4/14/26)

**Observation:**      **Work In Progress** – Work continues at Entry Canopy, including installation of sheathing at perimeter soffit and framing for linear metal soffit material at the center of the canopy.

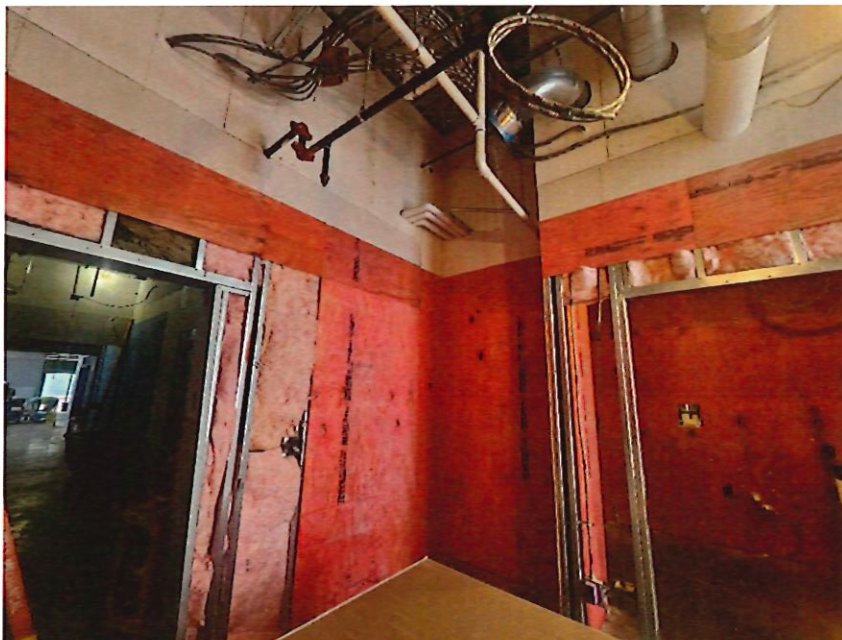
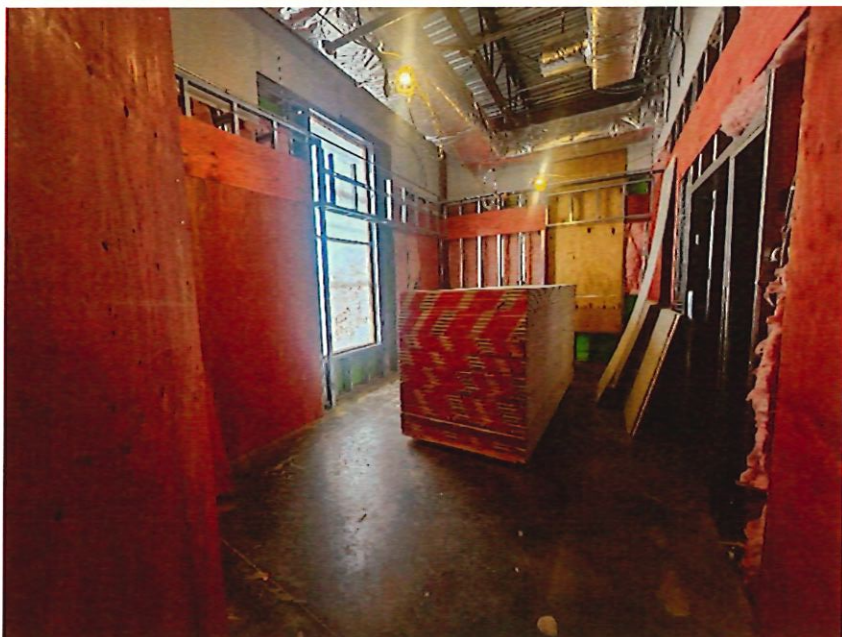
Item #60.03  
(4/14/26)

**Observation:**      **Work In Progress** – Work continues in POD 3, including installation of fire-resistant plywood backing in patient rooms at the south and west sides of the pod.

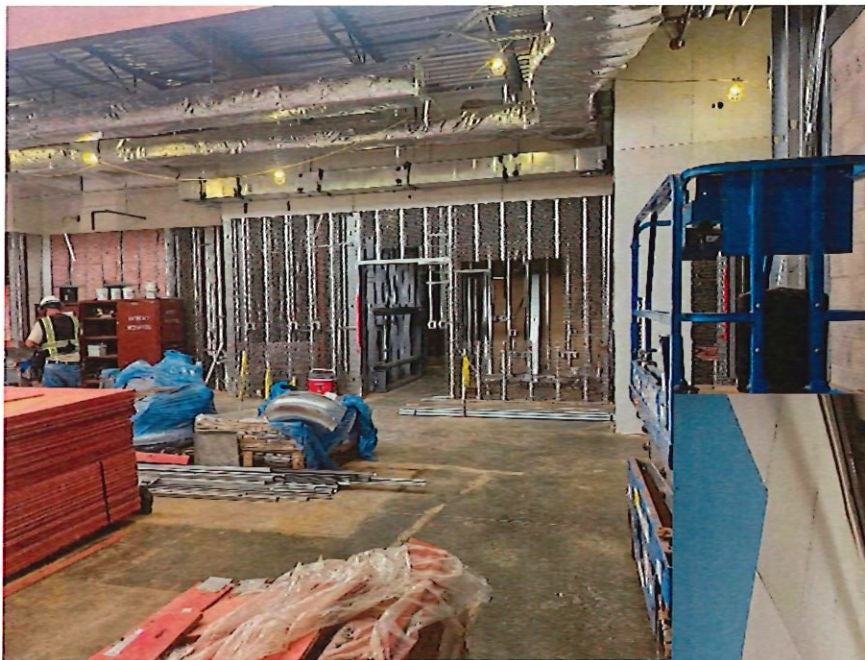
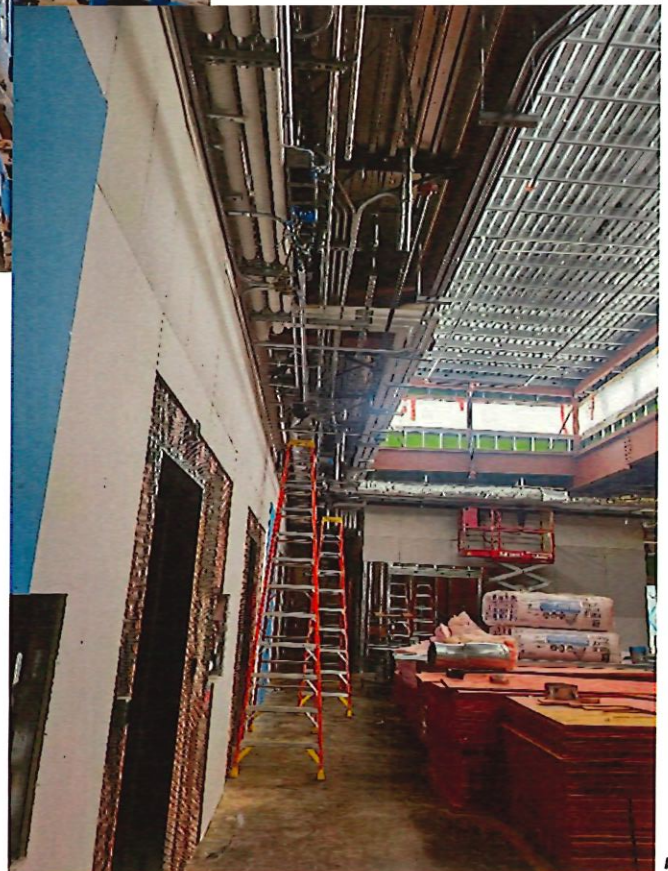
**Item #60.04**  
**(4/14/26)**

**Observation:**      **Work In Progress** – Work continues in Social Space 300, including window adjustment at Document 336 and the start of impact-resistant gypsum board installation at the west side of the space.

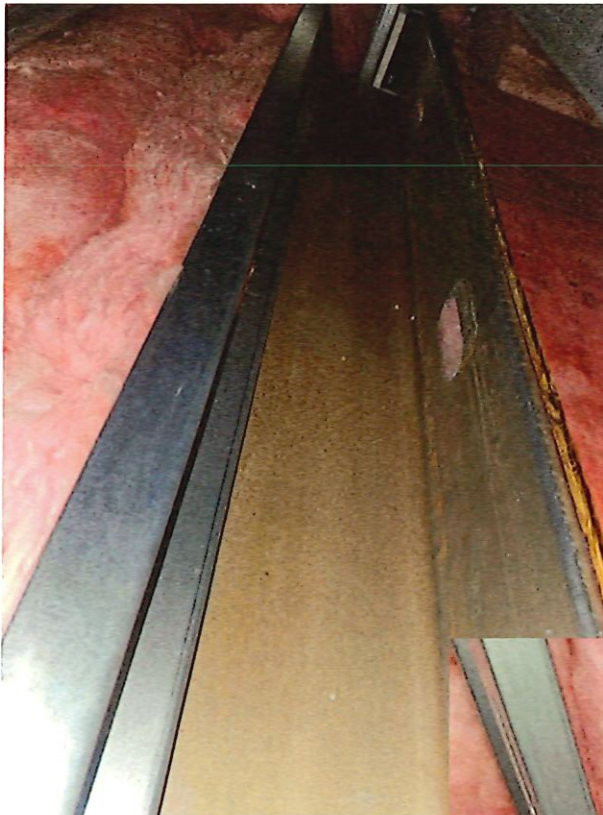
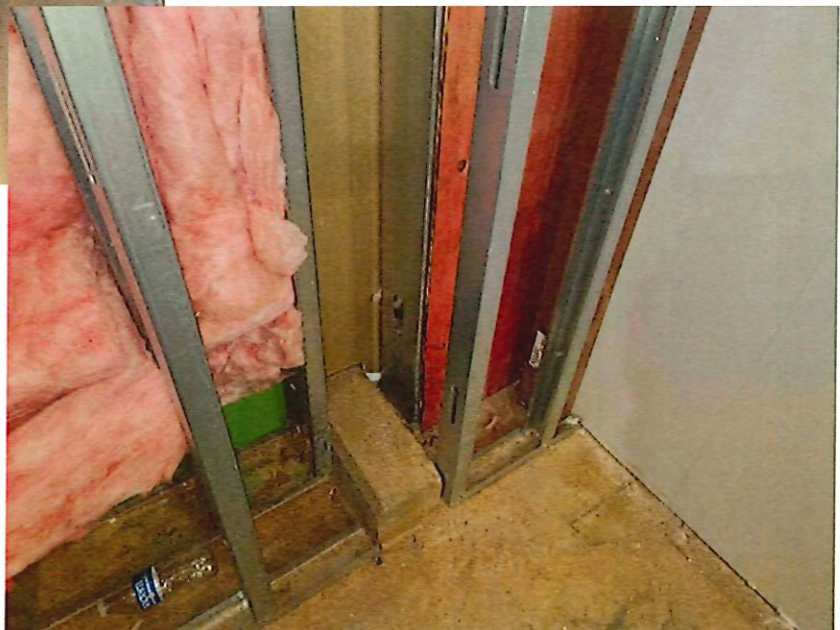
Item #60.05  
(4/14/26)

**Observation:**      **Work In Progress** – Fire-rated partition correction underway at the NW corner of Shared Patient Room 311A. Gypsum board on the corridor side of the partition now extends to exterior wall sheathing. Work continues to complete the patient room side of the wall, so it returns to the exterior wall sheathing.

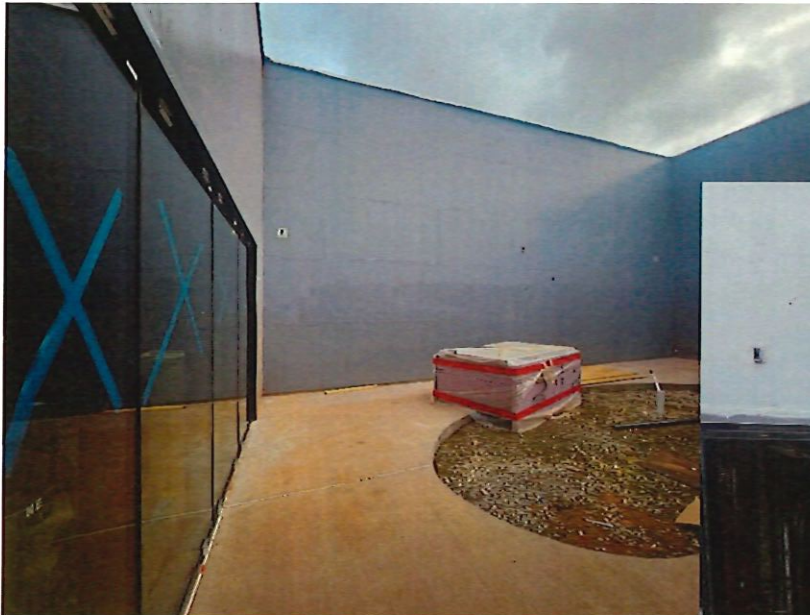
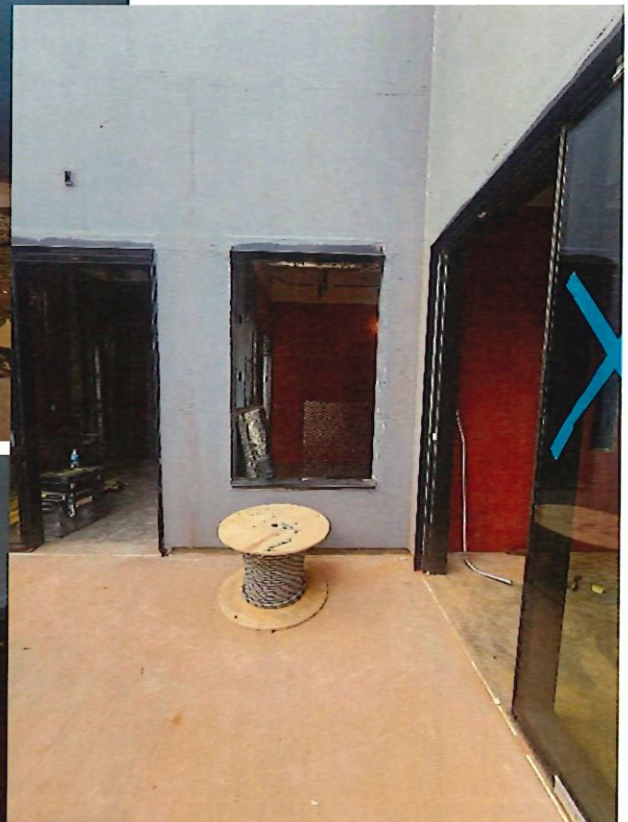
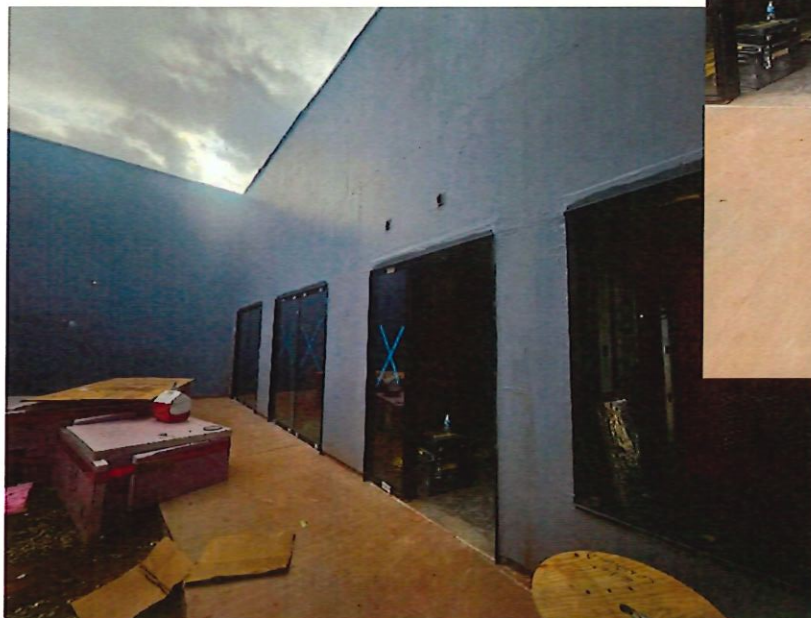
Item #60.06  
(4/14/26)

**Observation:**      **Work In Progress** – Glazing has started in all the courtyards, and caulking of the frames is underway.

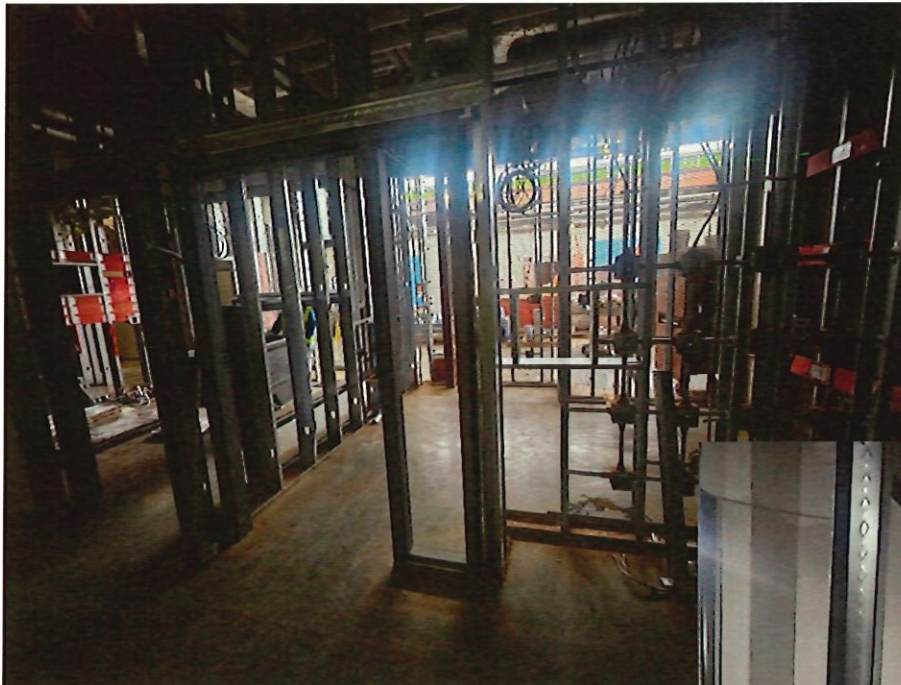
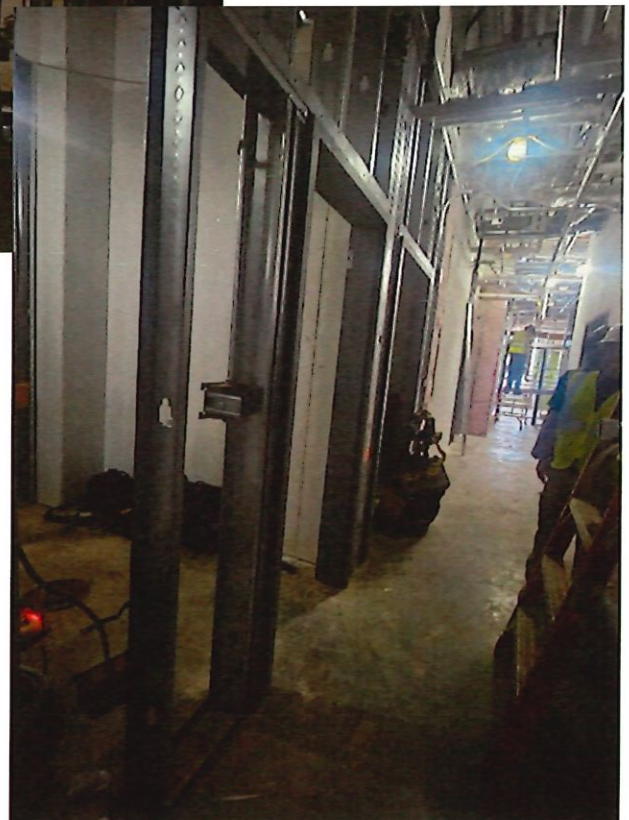
Item #60.07  
(4/14/26)

**Observation:**      **Work In Progress** – Hollow metal door frames are being installed in various locations throughout the building, including in Corridor 339B.

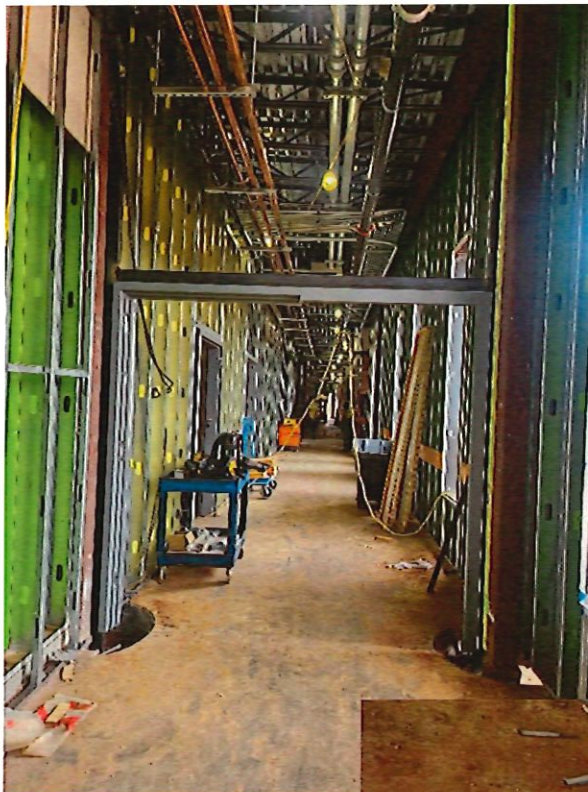
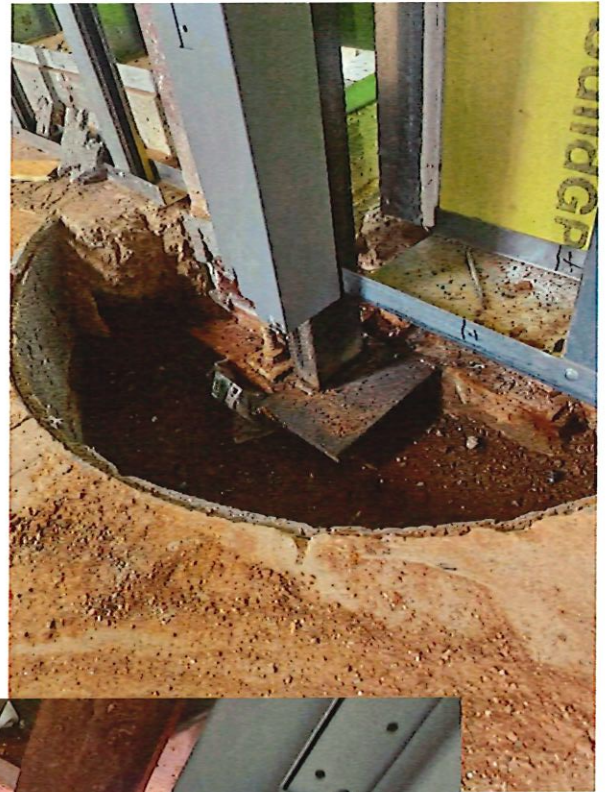
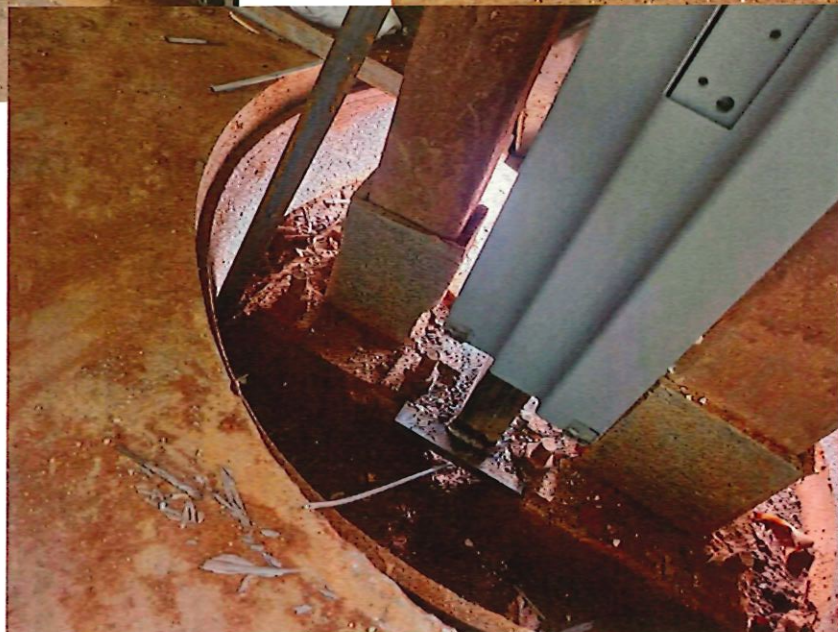
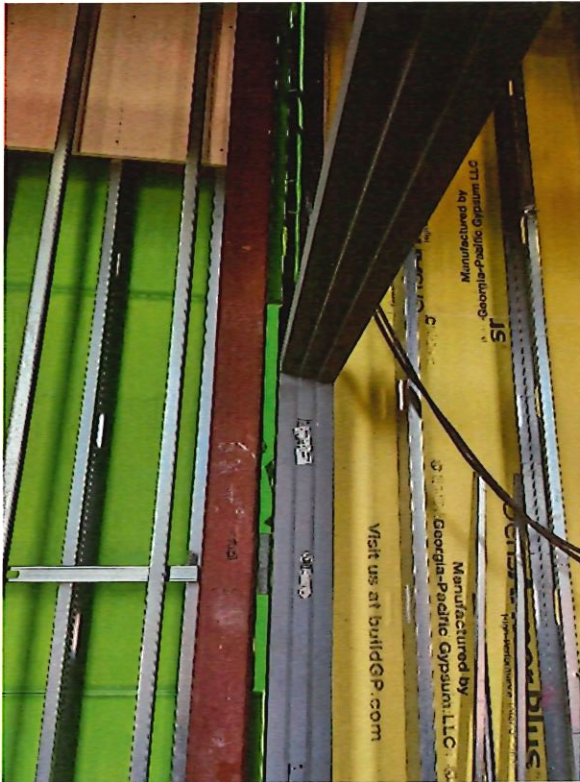
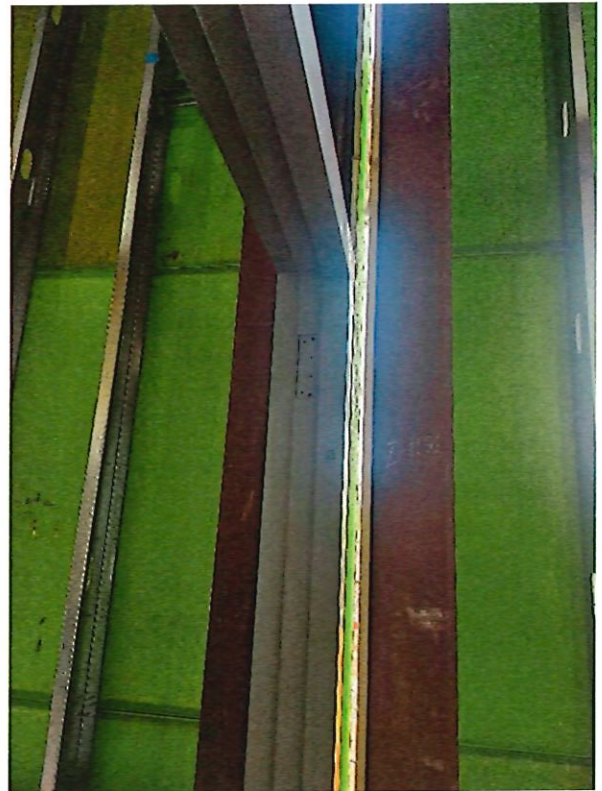
Item #60.08  
(4/14/26)

**Observation:**      **Work In Progress** – Hollow metal door frame at door 006B installed, including tube metal frame and welded connections to column base plates on grid 9B.2 on the south side of the expansion joint.

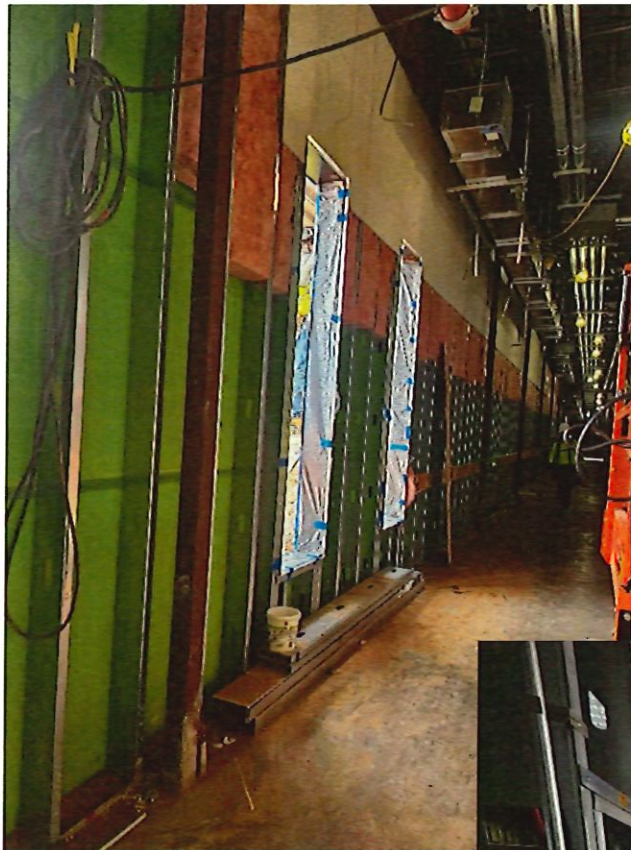
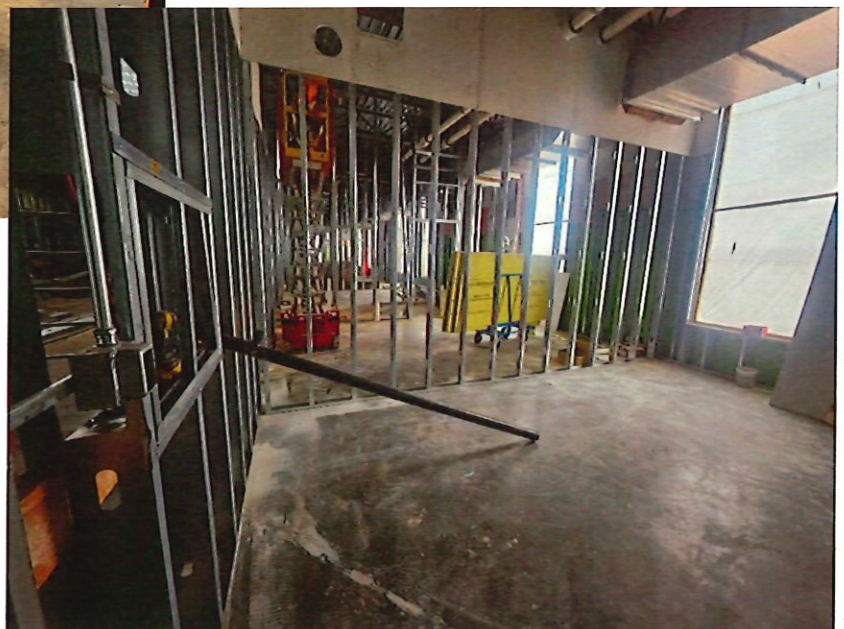
Item #60.09  
(4/14/26)

**Observation:**      **Work In Progress** – Work continues in Pod 1, including skirting and insulation at the west wall of Corridor 006A and at patient rooms along the east side of the pod.

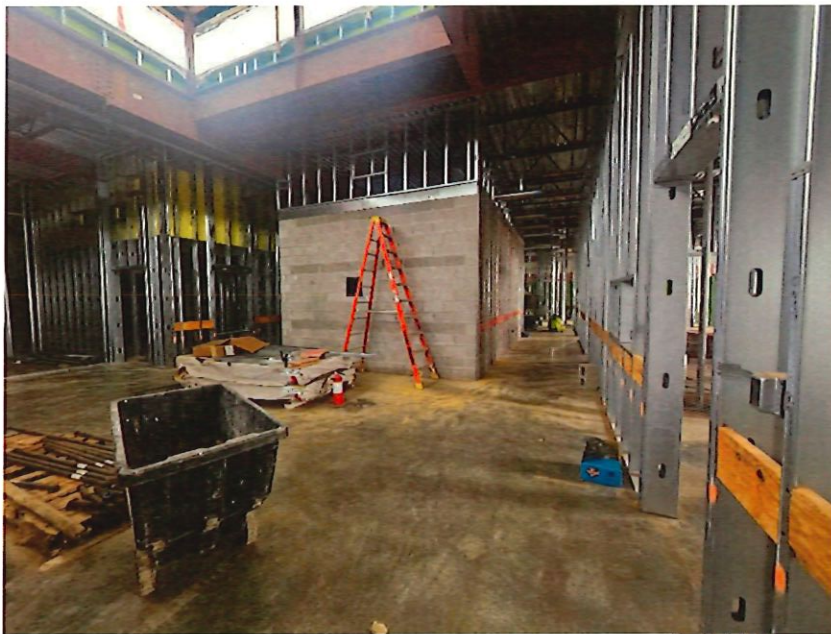
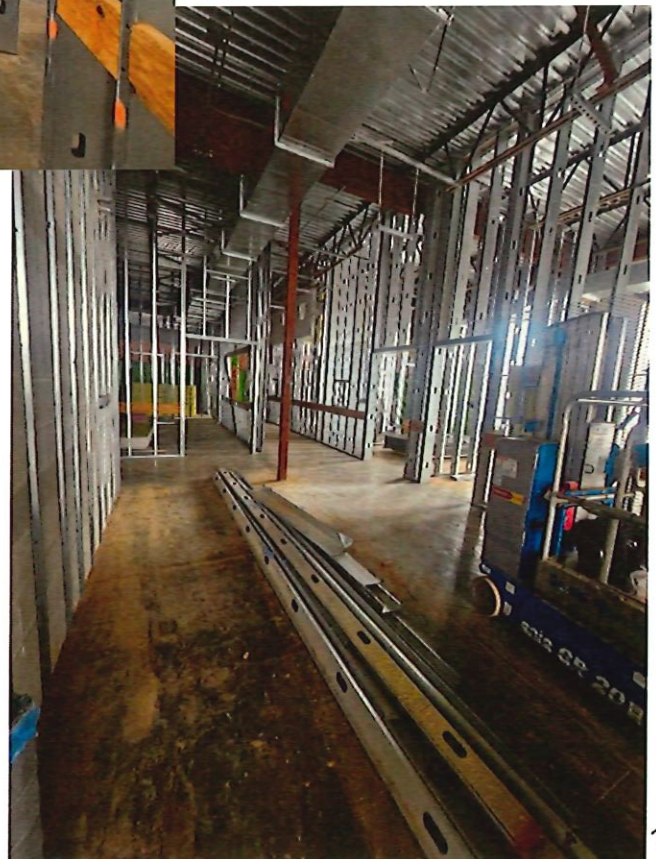
Item #60.10  
(4/14/26)

**Observation:**      **Work In Progress** – Work continues in Social Space 100, including mechanical piping configuration, plumbing, interior framing, and handrail blocking installation.

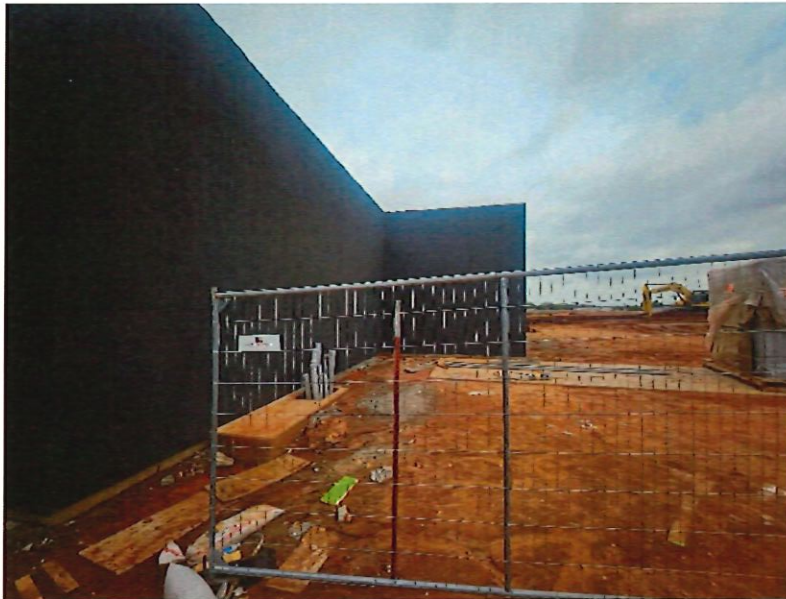
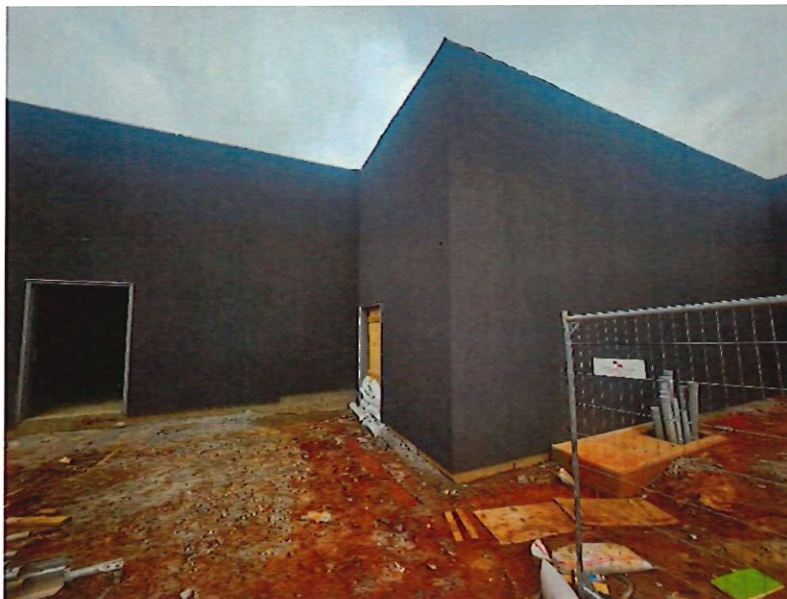
**Item #60.11**  
**(4/14/26)**

**Observation:**      **Work In Progress** – Plaster finish nearing completion at the east side of the connector Area X, adjacent to the generator set location.

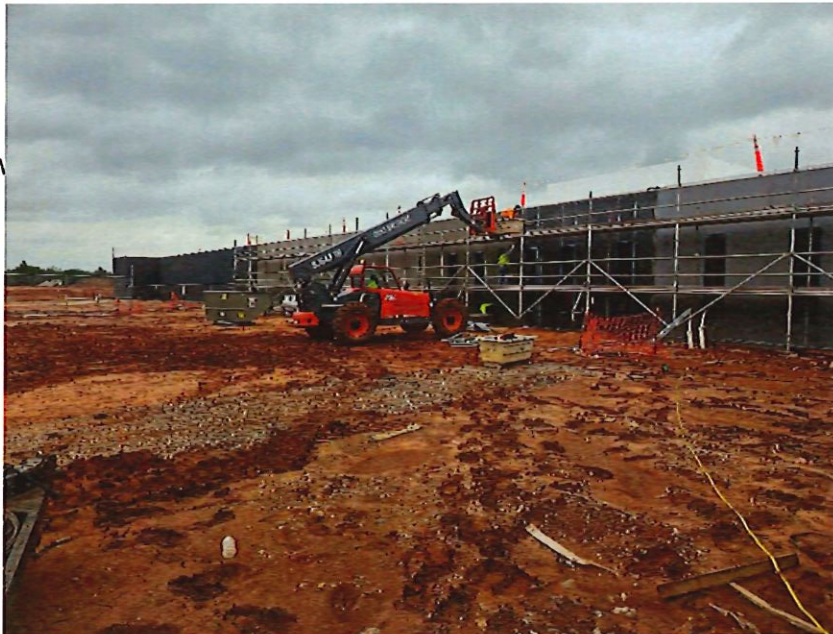
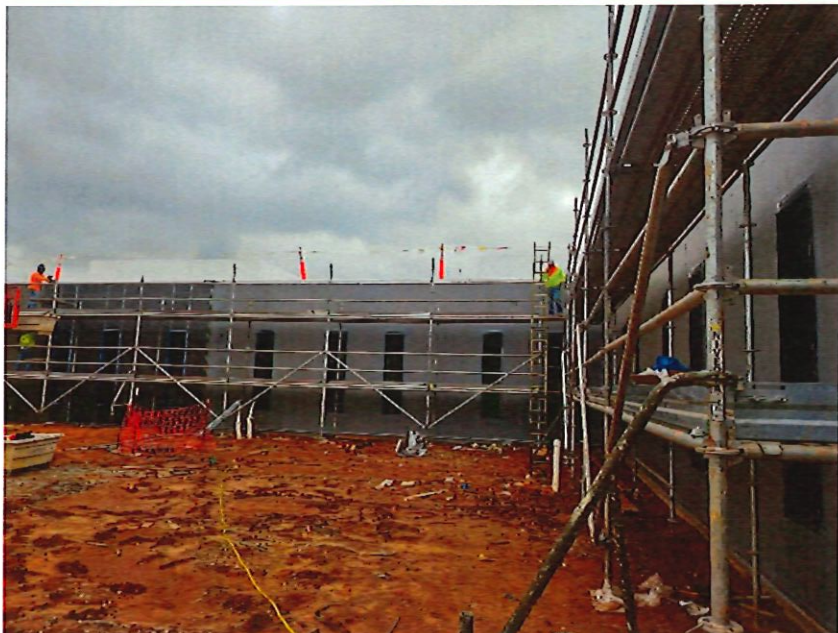
**Item #60.12**  
**(4/14/26)**

**Observation:**        **Work In Progress** – Plaster work continues at the west side of Pods 1 and 2, including plaster work in each stage of the installation process.

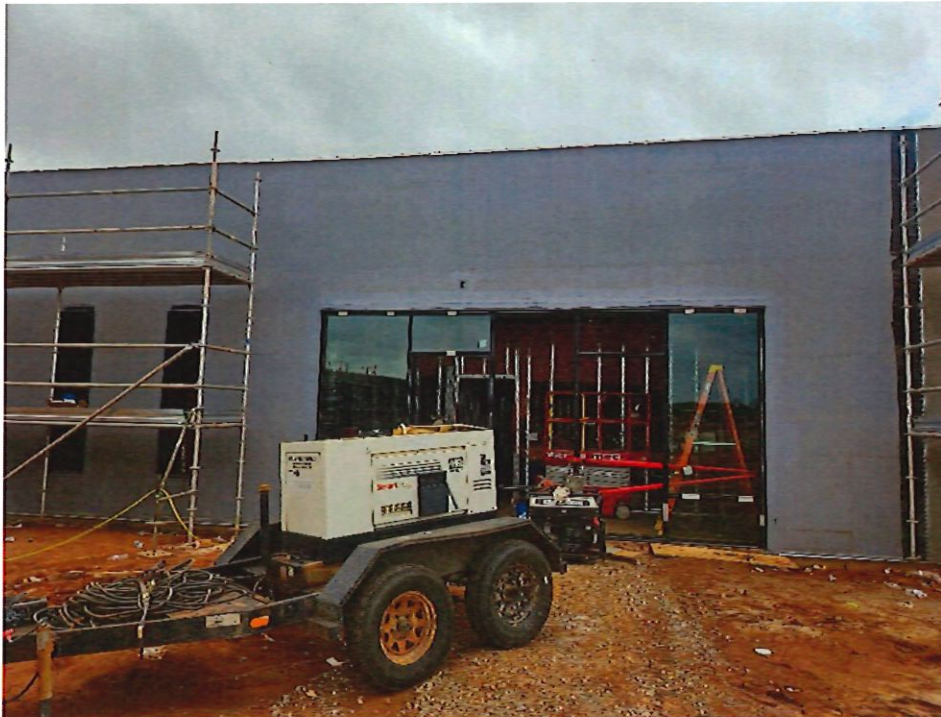
**Item #60.13**  
**(4/14/26)**

**Observation:** Work In Progress – Glazing installation continues at the north wall of Secure Corridor 006C.

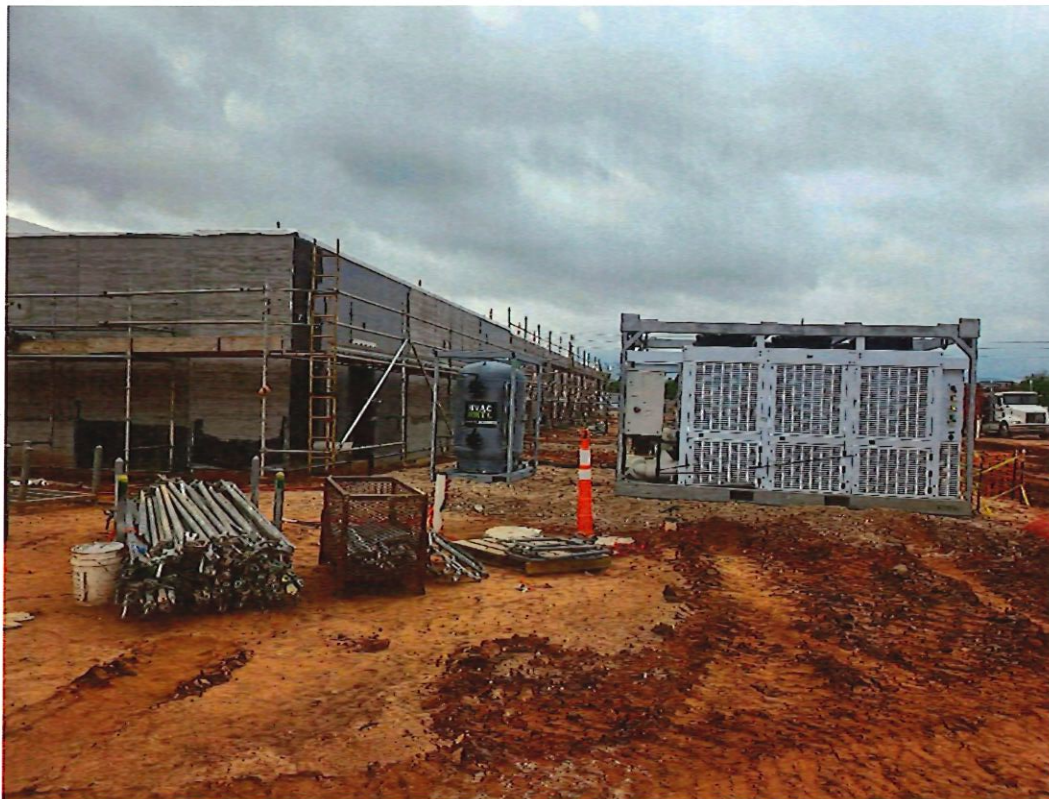
**Item #60.14**  
**(4/14/26)**

**Observation:**      **Work In Progress** – Temporary chiller located outside Mechanical Room 011A, awaiting hookup to provide temporary air conditioning to Pod 3 and Administration areas.

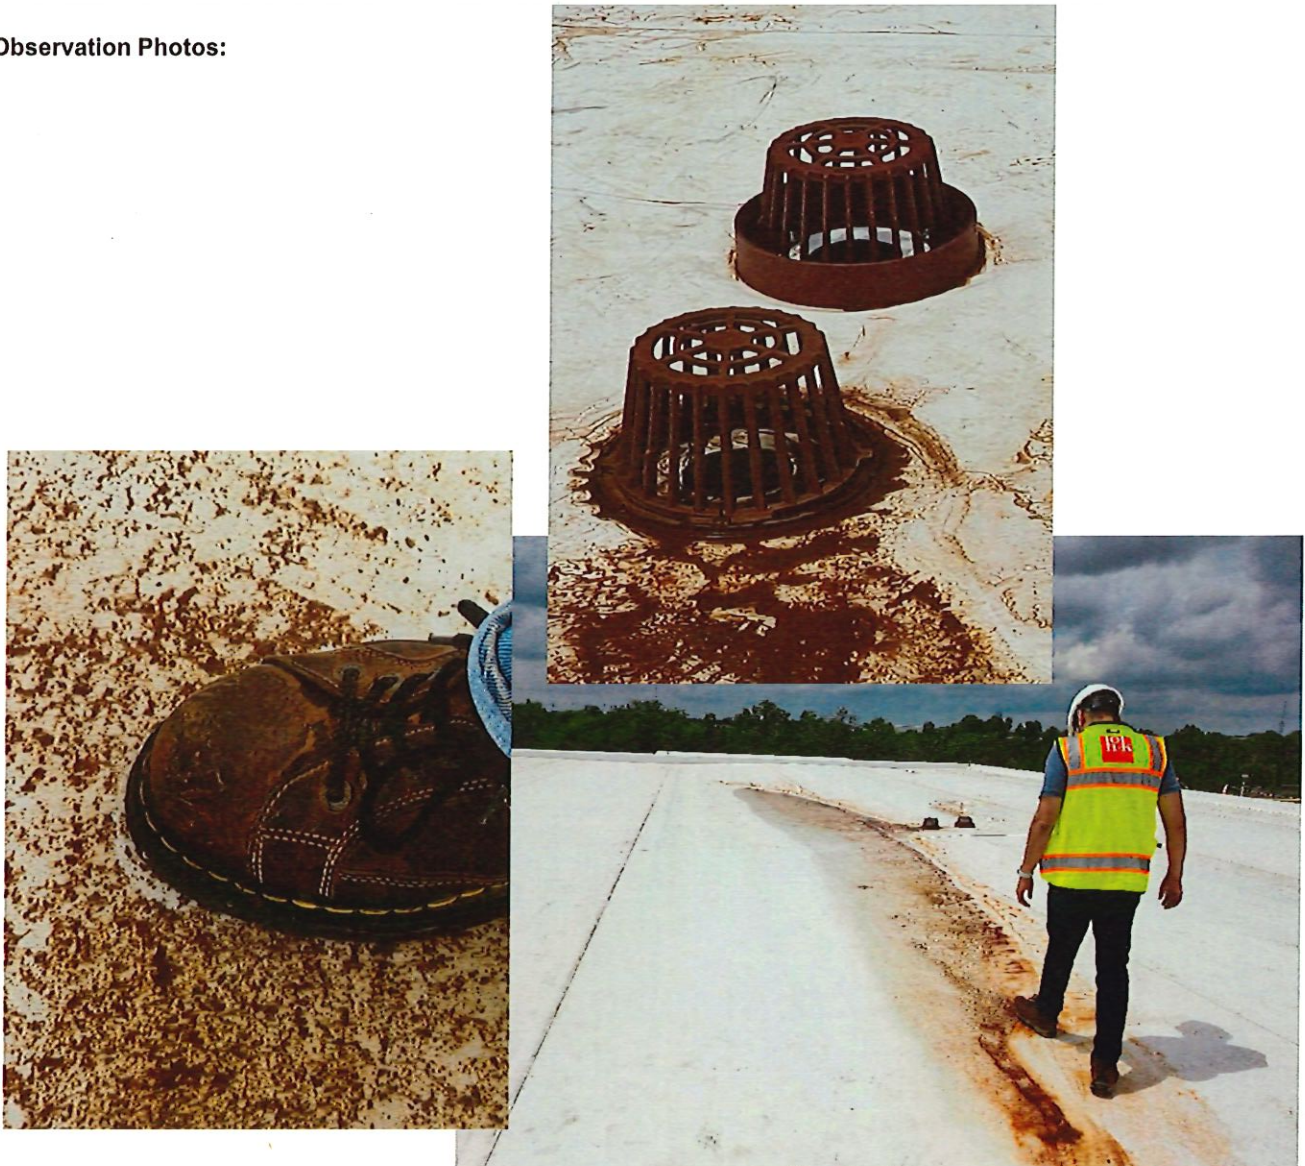
Item #60.15  
(4/14/26)

**Observation:**      **Work In Progress** – Roof membrane complete at Entry Canopy. Approximately 5/8" deep area of ponding just south of the roof drain due to a high spot in the roof insulation.

The roof membrane at the roof drains appears to have been cut approximately 3" smaller in diameter than the mouth of the roof drain assembly.

- A. Make repairs per 075423 – 3.10.H to eliminate ponding located south of the roof drain. Confirm roof slope meets requirements of 075423 – 2.5.D.3.a and b.
- B. Adjust the diameter of the hole in the roof membrane at the roof drains to match the roof drain assembly. Confirm installation meets Oklahoma Uniform Building Code Commission Rule 748:20-16-16

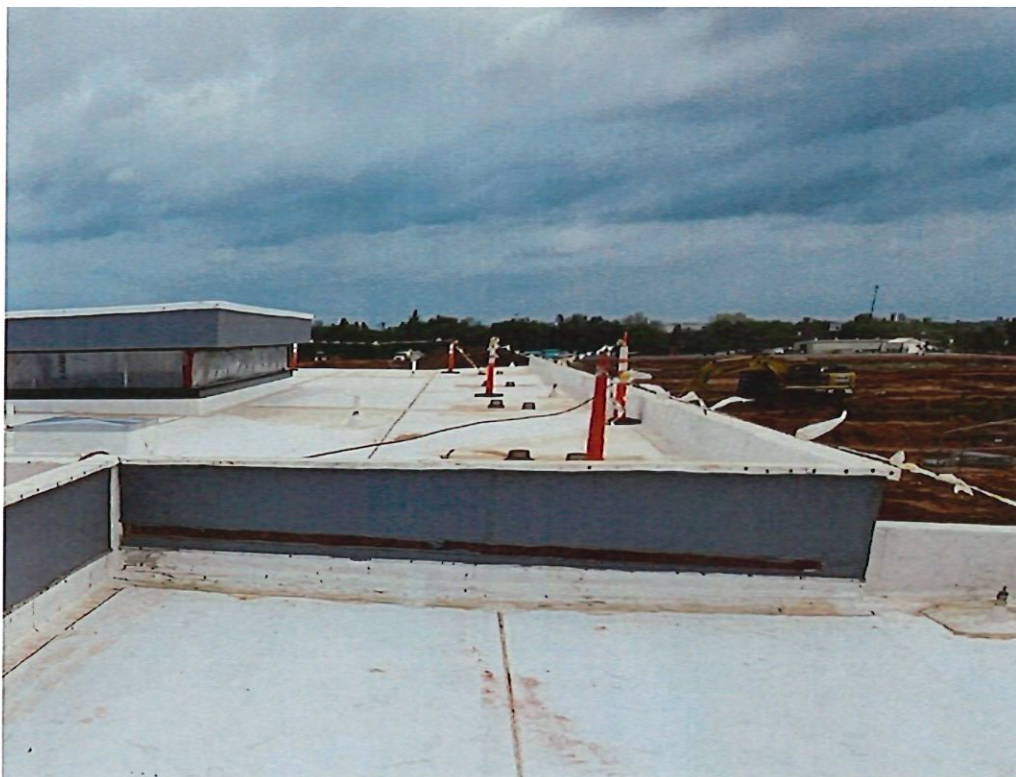
**Item #60.16**  
**(4/14/26)**

**Observation:**      **Work In Progress** – Section of structural steel appears to be exposed and interrupting the continuous plane of the air barrier/rain screen at the north parapet wall of the low roof over mechanical Room 010A.

**Action Items:**      A. Confirm air barrier and installation meet the requirements and the intent outlined in 072726-2.2.A, 072726-3.2.H, and 072726-3.4.A.

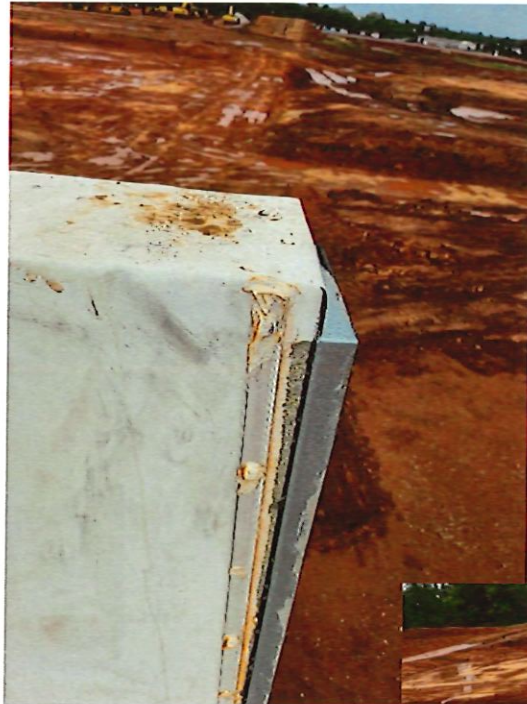
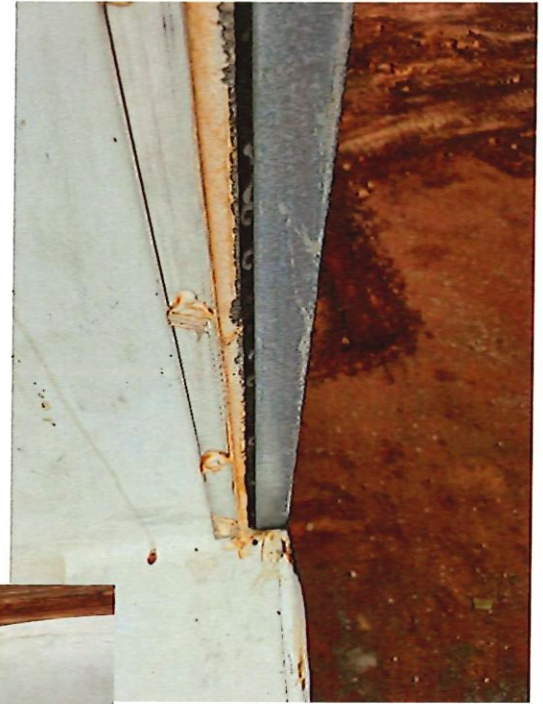
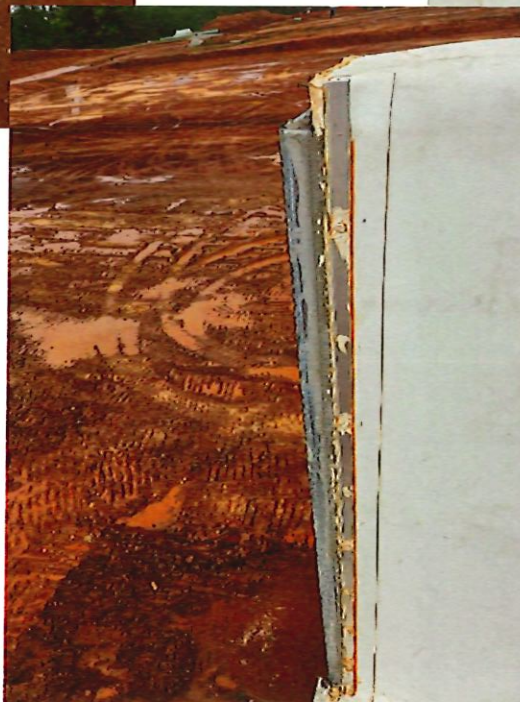
Item #60.17  
(4/15/26)

**Observation:**      **Work In Progress** – Plaster finish covering exposed ends of CMU has created a vertical joint between the plaster and the CMU.

**Action Items:**      A Flintco to ask the certified Carlisle installer about a warrantable membrane flashing strip solution to cover the joint.
